Service Bulletin

SUBJECT: Special Coverage Adjustment – Rear Fascia Heat Distortion or Hole from License Plate Lamps

**MODELS: 2010-2013 Chevrolet Camaro
Without Rear Tow Hooks (RPO VJR)**

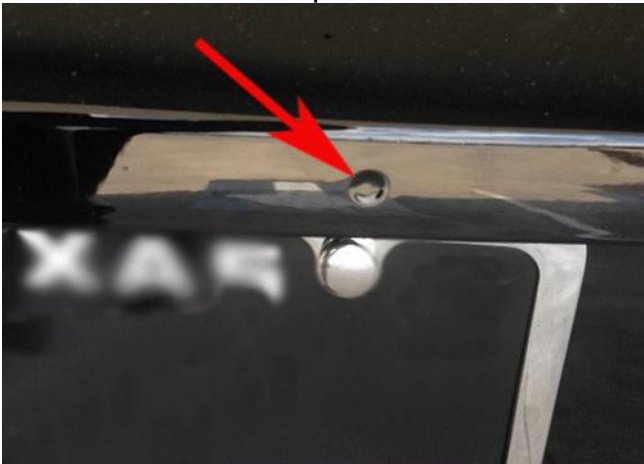
4178911

Use the following steps to replace the two rear license lamp housings and bulbs. If the rear bumper fascia is damaged (localized dimple caused by license lamp bulb) refer to the **Rear Fascia Repair** section of this bulletin.

1. Remove the rear bumper fascia. Refer to *Rear Bumper Fascia Replacement* in SI.

2. Using standard flexible part repair procedure, repair the affected area of the fascia.
3. *Refinish as required.
4. Reinstall the bumper fascia. Refer to *Rear Bumper Fascia Replacement* in SI.
