# Service Bulletin

**SUBJECT:** Special Coverage Adjustment – Diesel Fuel Odor

**MODELS:** 2010-2015 Chevrolet Express  
2011-2015 Chevrolet Silverado HD  
2010-2015 GMC Savana  
2011-2015 GMC Sierra HD  
Equipped with 6.6L Duramax Diesel Engine (RPO LML or LGH)

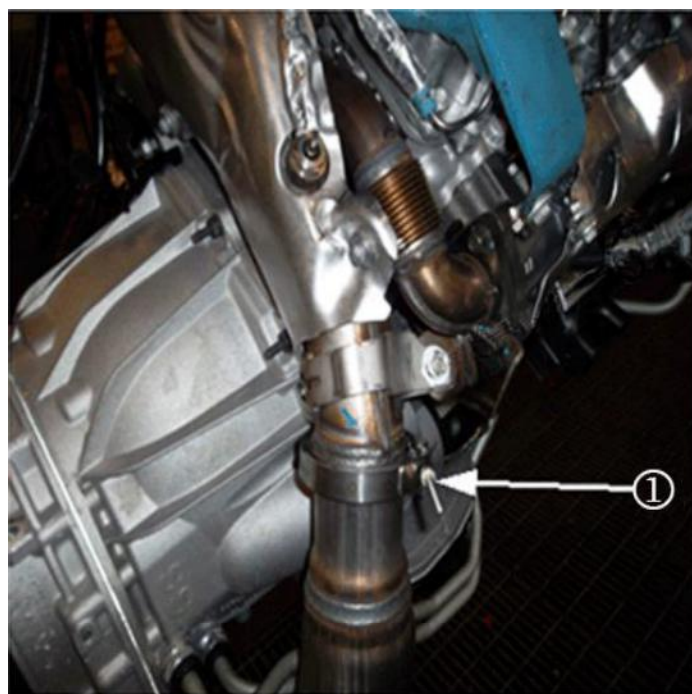
4257892

1. Verify that there is an exhaust leak between the turbocharger exhaust pipe and the downpipe. Refer to the appropriate diagnostic information in SI.
  - If there is NOT an exhaust leak between the turbocharger exhaust pipe and the downpipe, no further action is required. Inform the customer that any additional diagnosis and repairs are not covered under this special coverage.
  - If there is an exhaust leak between the turbocharger exhaust pipe and the downpipe, proceed to step 2.

2. Remove and discard the exhaust clamp between the downpipe and the turbocharger exhaust pipe (1) as shown in the illustration above.

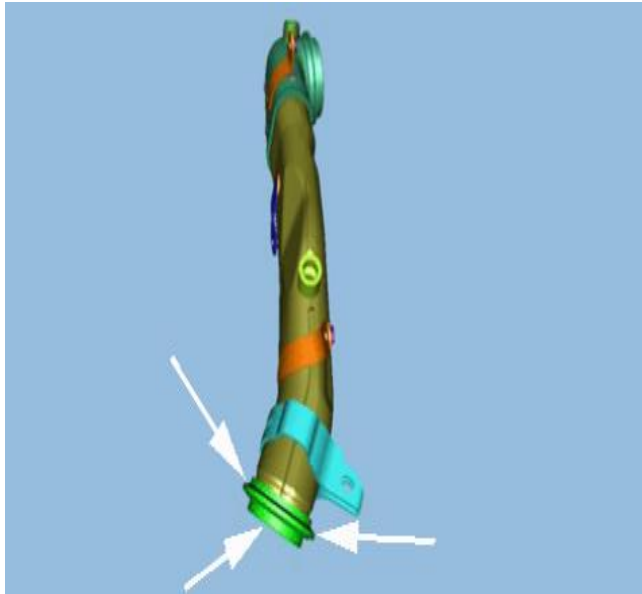
2749618

**Note:** The illustration above is the updated turbocharger exhaust pipe with a pilot flange.

- If the concern is NOT present, no further action is required
- If the concern IS still present, the turbocharger exhaust pipe may need to be replaced on trucks built prior to the breakpoints listed below with an updated turbocharger exhaust pipe with a pilot flange. If the turbocharger exhaust pipe on the customer's vehicle has the new flange, you should not need to replace it. Refer to *Turbocharger Exhaust Pipe Replacement* in SI.

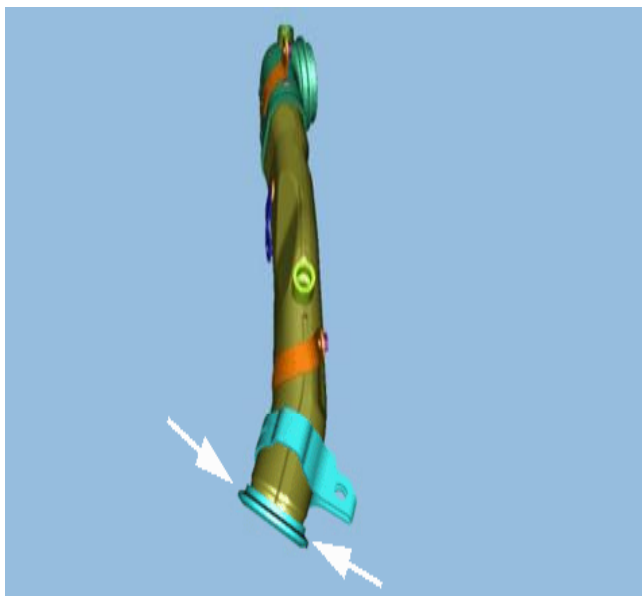
2749630

**Note:** The illustration above is the turbocharger exhaust pipe without a pilot flange.

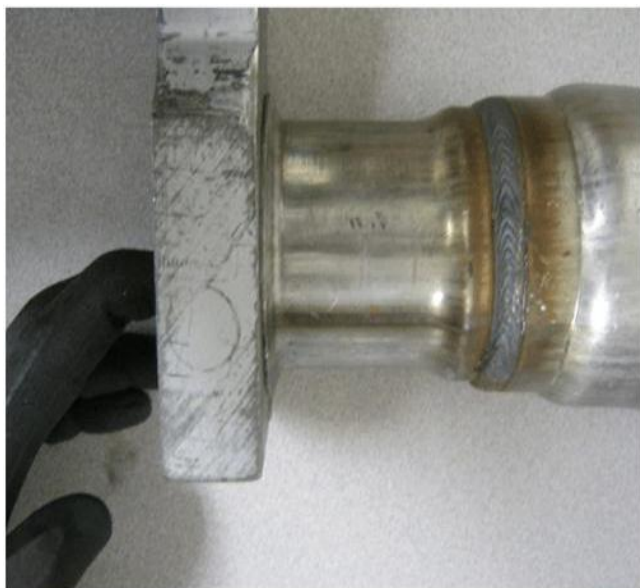
2748856

**Note:** In most cases it will not be necessary to replace the exhaust downpipe/catalytic converter assembly for this condition. However, if the mating flange on the exhaust downpipe/catalytic converter assembly is not true it is possible a leak may occur.

14. Verify the mating flange on the exhaust downpipe/catalytic converter assembly is true.

- If the mating flange is true, no further action is required.
- If there are gaps the converter may need replacing, but the new gasket should compensate for minor surface variation. It is preferred that the alignment process is attempted prior to replacing the converter. There have been very few cases that required the converter to correct this condition. Refer to *Catalytic Converter Replacement (LGH /LML)* in SI.
