# Program Bulletin

## CUSTOMER SATISFACTION PROGRAM

**SUBJECT:** Engine Harness Chafing On EGR Stud

**MODELS:** 2015 Chevrolet Silverado HD  
2015 GMC Sierra HD  
Equipped with the Duramax Diesel 6.6L Engine (RPO LML)

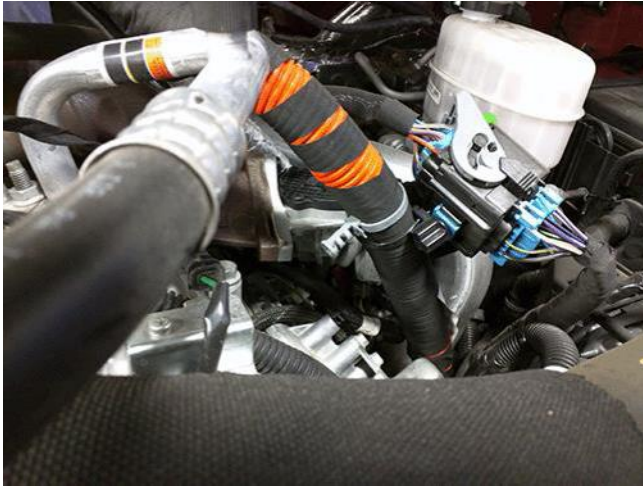
4290170

1. Open hood and install fender covers.
2. Inspect the main engine harness for any damage. If any damage is found, repair wire(s). Refer to *Wiring Repairs* in SI before proceeding to step 2.
