Program Bulletin

CUSTOMER SATISFACTION PROGRAM

SUBJECT: Front Knuckle to Hub Attachment Torque

MODELS: 2014-2016 Chevrolet Cruze

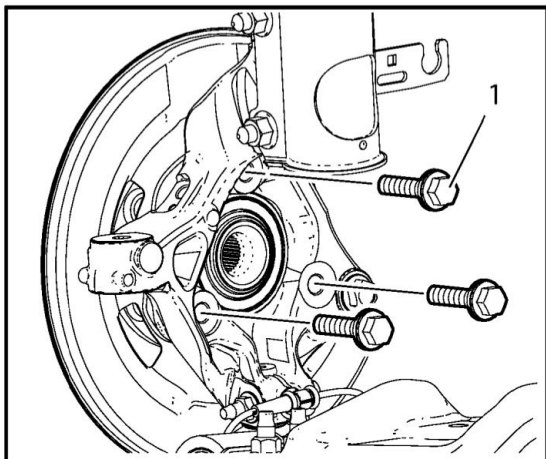
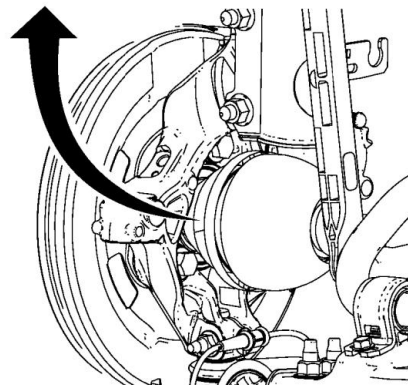
2027764

2. Locate the front driver/passenger side bearing/hub bolts.

3. Observe that the fasteners are all present and that no damage has occurred to the bearing/hub. If any damage has occurred replace the bearing/hub and fasteners. Refer to *Front Wheel Bearing and Hub Replacement*.
4. Tighten the bearing/hub bolts (1) in 2 passes. Use the *EN-45059* angle meter. Refer to *Front Wheel Bearing and Hub Replacement* in SI. Ensure to tighten all front driver side wheel bearing/hub bolts.
 - a. First pass to **100 Nm (74 lb ft)**
 - b. Second pass to **20 – 35 degrees**
5. Repeat steps 2 through 4 for the passenger side bearing/hub bolts.
6. Lower the vehicle. Refer to *Lifting and Jacking the Vehicle* in SI.
