NUMBER: 21-070-15

GROUP: Transmission and Transfer Case

Flash: PTU Motor Position Enhancements

2014-2015	(KL)	Jeep Cherokee
2015	(UF)	Chrysler 200

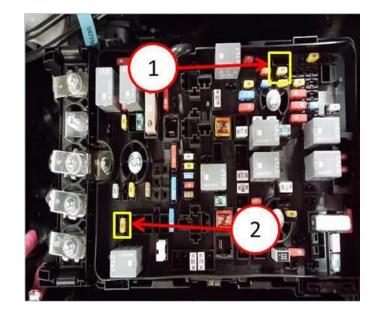
Fig. 1 Module Fuse Locations

- 1 F76 RMD 4WD
- 2 F10 PTU 4WD
- 8. Is the vehicle stuck in 4 wheel Low/Lock?
 - a. Yes >>> Proceed to Step #9.
 - b. No >>> Proceed to Step #13.
- 9. Raise the vehicle on the hoist.
- 10. Aggressively rotate/rock one of the rear wheels back and forth, in order to free up the axle lock shift sleeve and relieve the torque lock in the system.
- 11. Perform a key cycle, change the ignition position from lock to run, it is not necessary to start the engine. You should hear the motor in the rear axle actuator move while the relearn process is occurring immediately after key-on.

- a. Turn the ignition off.
- b. Pull fuse F76 (RDM 4WD, 20 amp) in the PDC (Power Distribution Center) (Fig. 1).
- c. Turn the ignition key to the RUN position and perform the PTU flash.
- d. When the flash is complete, turn the ignition key OFF and reinstall fuse F76.
