Service Bulletin

SUBJECT: Service Update for Inventory and Customer Vehicles
Harness Trapped Under MBEC
Expires with Base Warranty

MODELS: 2016 Chevrolet Silverado HD
2016 Chevrolet Silverado LD
2016 GMC Sierra HD
2016 GMC Sierra LD

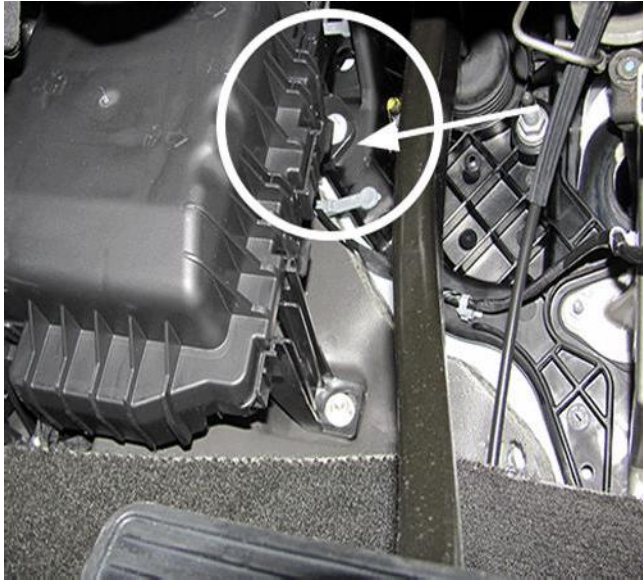
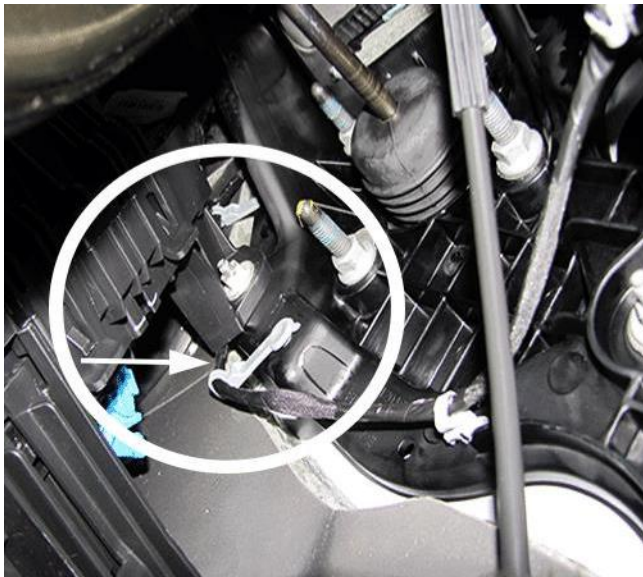
- If the brake clutch harness is routed as shown above (behind the body wiring harness junction block stand off), no further action required.

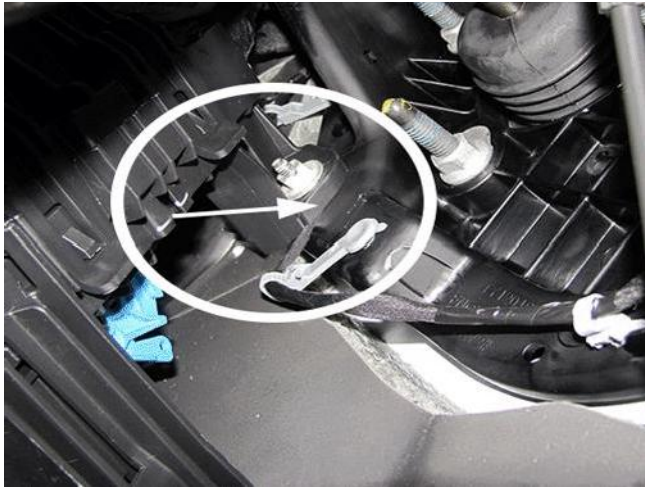
4340824

- If the brake clutch harness is trapped or pinched under the body wiring harness junction block stand off as shown, continue to step 3.
3. Remove the 3 body wiring harness junction block nuts.
 4. Inspect the brake clutch harness for any damage and repair as necessary. Refer to *Wiring Repairs* in SI.
 5. Gently lift the body wiring harness junction block and reroute the brake clutch harness away from the mounting stud of the body wiring harness junction block.
 6. Install the body wiring harness junction block back in place and install the mounting nuts.
