Service Bulletin

Bulletin No.: PIP3423L

Date: October, 2015

Subject: DTC P0016 P0017 P0018 P0019 P0008 P0009

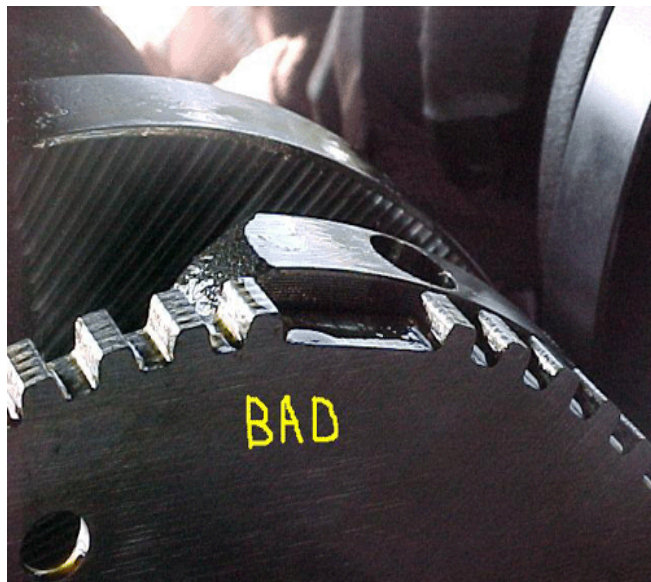
1873655

The reluctor for the crankshaft sensor pressed onto the rear of the crankshaft may have moved.

Crankshaft with bad reluctor wheel

Note: The distance can be offset either clockwise or counter clockwise. Both will result in these codes.

If the reluctor has moved then replace crankshaft.
