Service Bulletin

Bulletin No.: PIP3423M

Subject: DTC P0016 P0017 P0018 P0019 P0008 P0009

Models: 2007-2016 Buick Enclave
2005-2016 Buick LaCrosse Allure (Canada Only)
2013-2015 Cadillac ATS
2013-2016 Cadillac XTS
2004-2015 Cadillac CTS
2004-2016 Cadillac SRX
2004-2011 Cadillac STS
2010-2015 Chevrolet Camaro
2015-2016 Chevrolet Colorado
2008-2016 Chevrolet Equinox
2012-2016 Chevrolet Impala
2008-2012 Chevrolet Malibu
2009-2016 Chevrolet Traverse
2007-2016 GMC Acadia
2015-2016 GMC Canyon
2010-2016 GMC Terrain
2007-2009 Pontiac G6
2008-2009 Pontiac G8, Torrent
2007-2010 Saturn Aura, Outlook
2008-2010 Saturn Vue
Equipped with 2.8L LP1, 2.8 LAU, 3.0 LF1, LFW 3.6L LY7, LLT, or LFX HFV6 engines

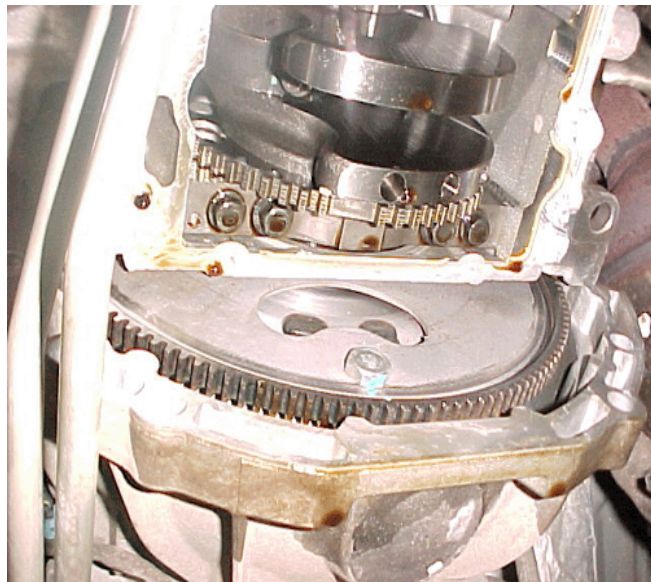
1873652

The reluctor for the crankshaft sensor pressed onto the rear of the crankshaft may have moved.

Refer to attached photographs for exact location.

If the reluctor has moved then replace crankshaft.
