# Service Bulletin

Bulletin No.: PIP5296B

**Subject:** Growl Or Grind Noise - Front Differential Drive Pinion Gear - Or Differential Carrier Bearing

**Models:** 2015 Buick Enclave, LaCrosse, Regal  
2015 Cadillac SRX, XTS  
2015 Chevrolet Equinox, Impala, Malibu, Traverse  
2015 GMC Acadia, Terrain  
Equipped with 6T70 or 6T75 Automatic Transmission (RPOs M7U, M7V, M7W, M7X, MH2)

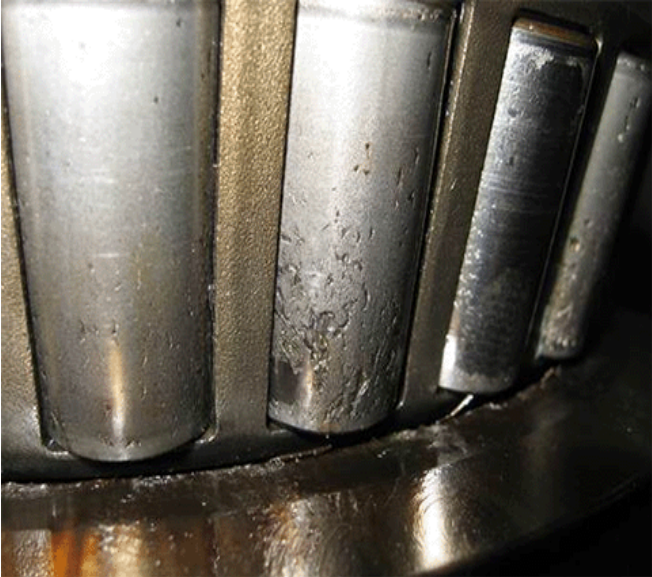
4280613

Some customers may comment on a grind or growl noise from the transmission while moving. Disassembly of the transmission may find a Front Differential Drive Pinion Gear bearing(s) or Differential Carrier bearing(s) that are pitted or spalled.

Below are sample images of bearings / races that are pitted or spalled.

If a pitted or spalled Front Differential Drive Pinion Gear bearing(s) (480), SI# 1726803, and/or Differential Carrier bearing(s) (485, 487), SI# 1726804, are found please contact TAC prior to attempting to remove the distressed bearing(s) from

Do not proceed with any further repairs.
