Service Bulletin

Bulletin No.: PIP5335

Subject: SES Lamp With Camshaft Position Codes

Models: 2015-2016 Cadillac Escalade
2014-2016 Chevrolet Silverado 1500
2015-2016 Chevrolet Suburban, Tahoe
2014-2016 GMC Sierra 1500
2015-2016 GMC Yukon Yukon XL
Built with RPO's 4.3L 5.3L 6.2L L83 L86 LV3

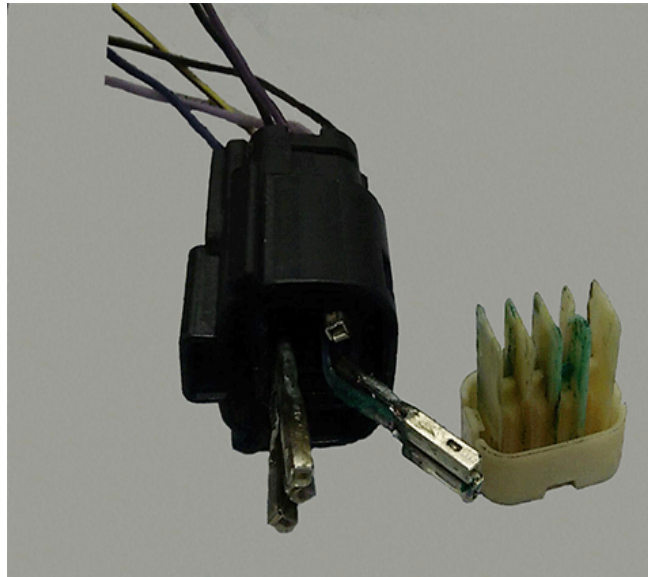
4284436

A vehicle may be setting DTC's P0340 and P0341 at times

If normal SI Diagnostics does not isolate the concern, inspect for corrosion in connector X154 located on the front cover next to the vacuum pump.

If this condition is encountered repair as needed.
