Service Bulletin

Subject: SES Lamp P0171 P0174

Models: 2007 - 2014 Cadillac Escalade
2007 - 2013 Chevrolet Avalanche, Silverado
2007 - 2014 Chevrolet Suburban, Tahoe
2007 - 2016 Chevrolet Silverado HD
2007 - 2015 GMC Sierra
2007 - 2014 GMC Yukon
2007 - 2016 GMC Sierra HD
With V-8 engine
4.8L L20
5.3L LC9, LMF, LMG, LY5
6.0 L76, L96, LC8, LY6, LZ1
6.2 L9H, L92

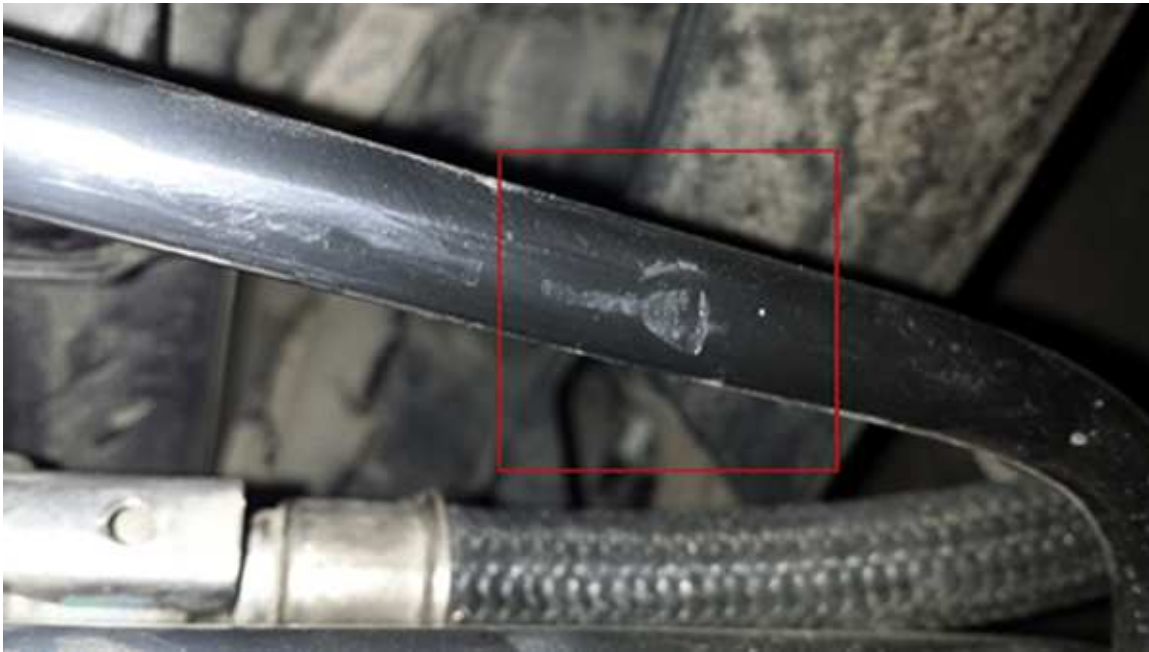
The engine cover can cause a rub through on the PCV tube located at the left rear of the intake manifold, just above the fuel line connection
