# Service Bulletin

**Subject:** Unable To Achieve Preload On Pinion Bearings 9.5/9.76 Inch Rear Axles

**Models:** 2014-2016 Chevrolet Silverado  
2015-2016 Chevrolet Tahoe, Suburban  
2014-2016 GMC Sierra  
2015-2016 GMC Yukon  
2015-2016 Cadillac Escalade  
Equipped with 9.5 inch or 9.76 inch rear axle.

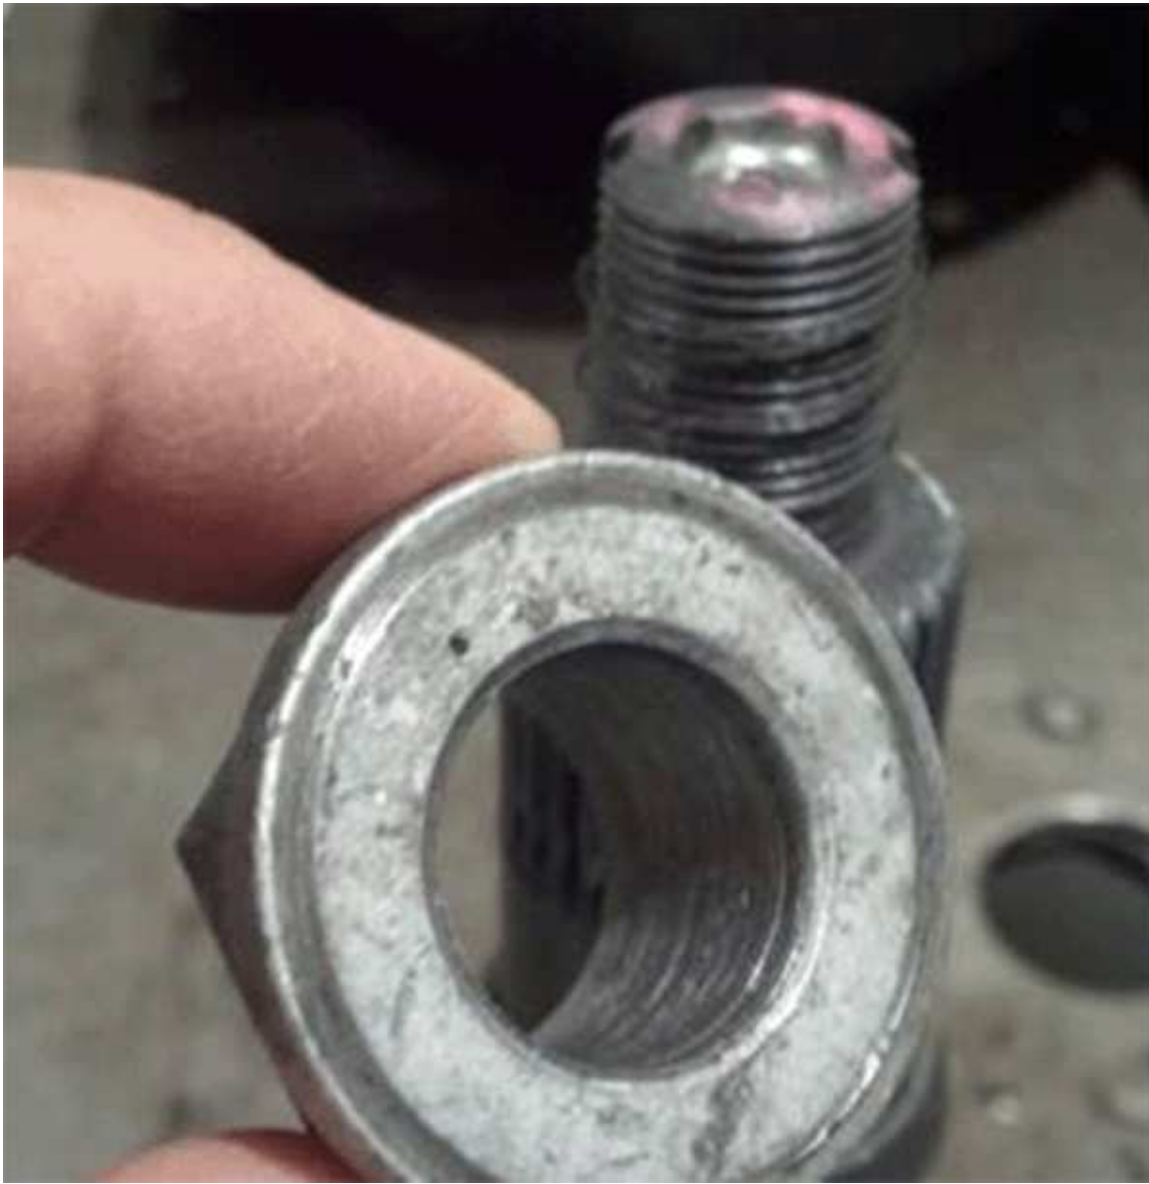
Technicians may be unable to achieve pre-load when setting up the pinion bearing pre-loads during reassembly of the 9.5/9.76 inch rear axles. Reports from the field include breaking of sockets, breaker bars, ratchets and pinion holding tool without achieving preload. Also we have seen pinion gears with stripped threads.

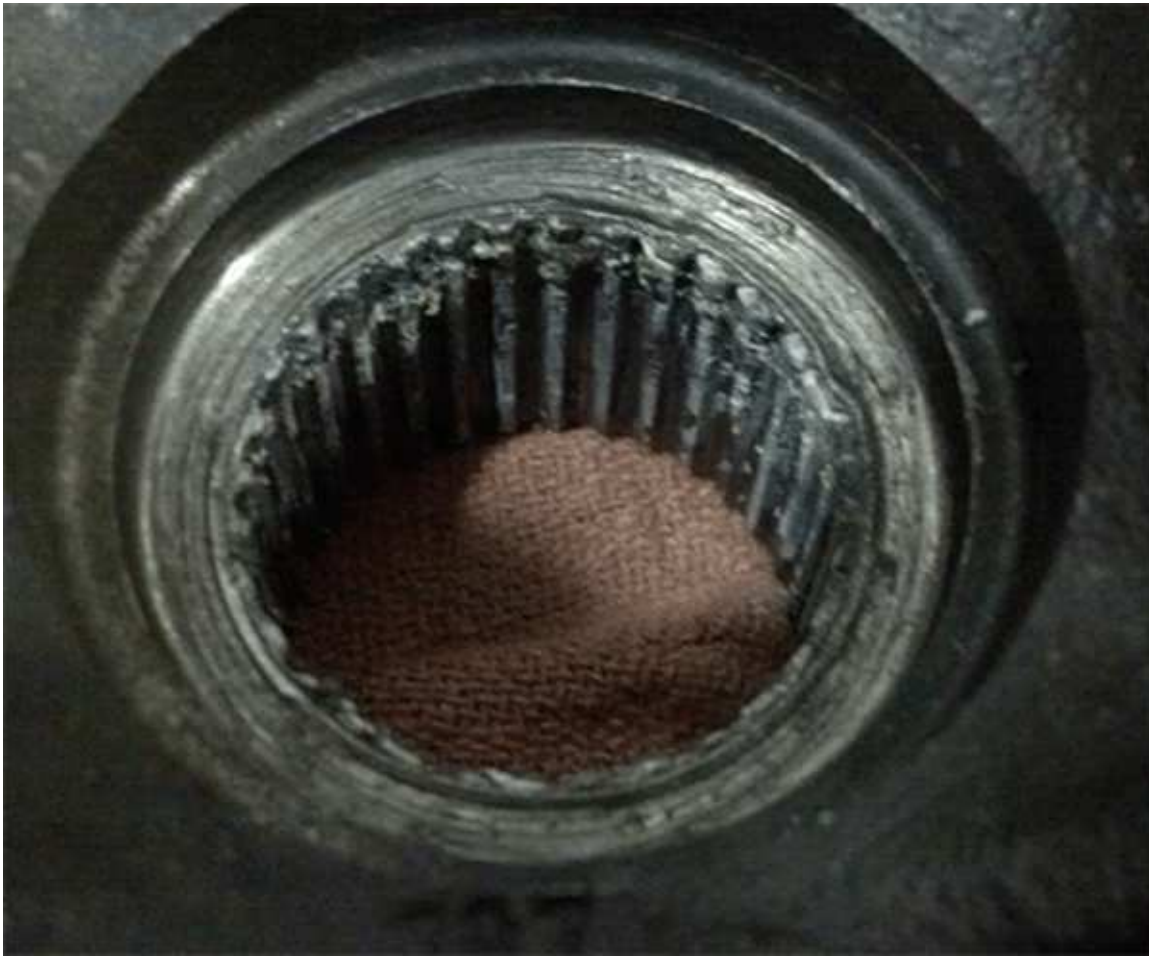
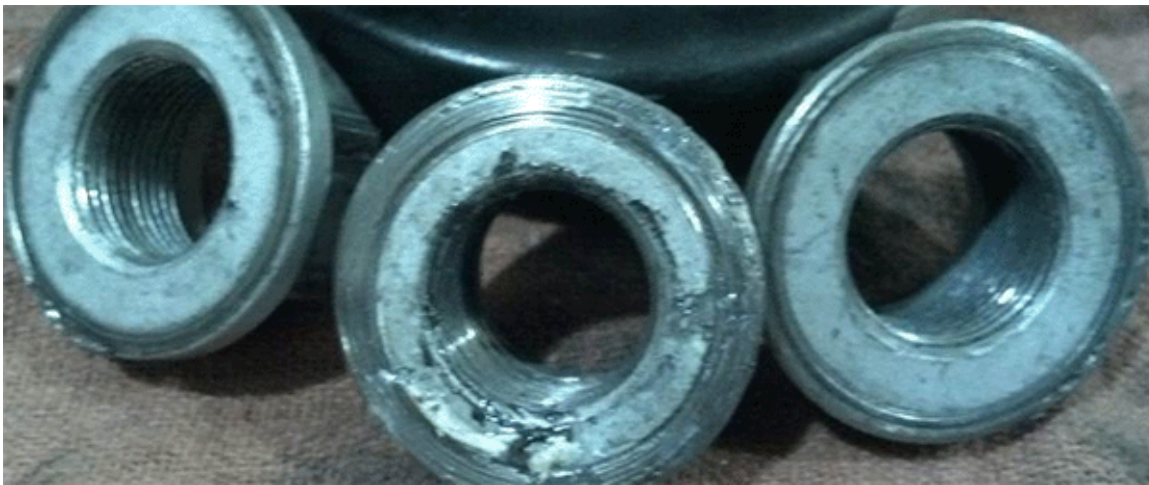
This has been identified to be caused when reusing a pinion flange that has imperfections in the mating surface where the nut contacts the flange. In rare occasions it has also been experienced with a new flange as the nut and flange mating surface start to wear into each other with high pressure associated with drawing the bearing and flange onto the gear. When there is extremely high amounts of torque applied to the pinion nut it is possible to deform the nut which starts the thread damage.

To aid in assembly the following information can be used in conjunction with Differential Drive Pinion Gear Bearing Replacement procedure in service information. With the pinion flange started onto the pinion gear install washer part number 11609638 onto the pinion shaft between the flange and nut.

Tighten the pinion nut until you achieve 10 lb in. (1.0 Nm) rotating torque.

Back the nut off and remove the washer.

Tighten the nut back down until you achieve 15 lb in. (1.7 Nm) for used bearings or 20 lb in (2.25 Nm) for new bearings.
