Service Bulletin

Bulletin No.: PIT4946A

Subject: Intermittent ABS Codes, No Communications, No Start and/or Various Electrical Concerns

Models: 2008 - 2012 Buick Enclave
2009 - 2012 Chevrolet Traverse
2008 - 2012 GMC Acadia
2008 - 2010 Saturn Outlook

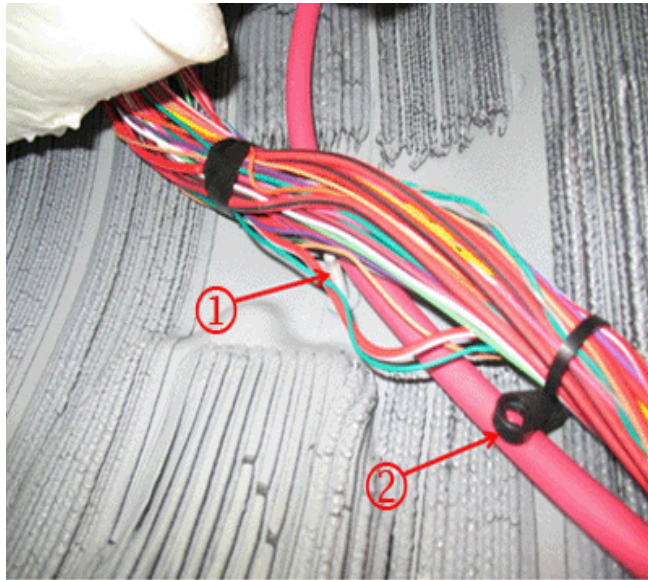
2359346

During diagnosis, it may be found there are ABS codes, and/or No communication codes. This concern may be caused by a wire harness chaffing on a stud on the right front floor pan/cowl area. This happens when the wire harness is not properly attached to the stud on the floor/cowl area.

1. Stud on the floor pan/cowl area.
2. Zip Tie with eyelet.

The picture above show the eyelet of the zip tie is not attached to the stud. Inspect the wire harness for any damaged wires and repair as necessary. Make sure the zip tie is attached to the stud on the floor pan.
