Service Bulletin

Bulletin No.: PIT5427A

Subject: Service StabiliTrak ABS AWD Suspension Control And / Or SES MIL

Models: 2010-2016 Chevrolet Equinox
2010-2016 GMC Terrain
With Any Combination of DTCs C0196 C0186 C0287 C0710 C0045 C0050 C0800 U0073
U0074 U0077 U0125 U0126 U0100 U0101 U0121 U0415 U0432 U0121 U0140

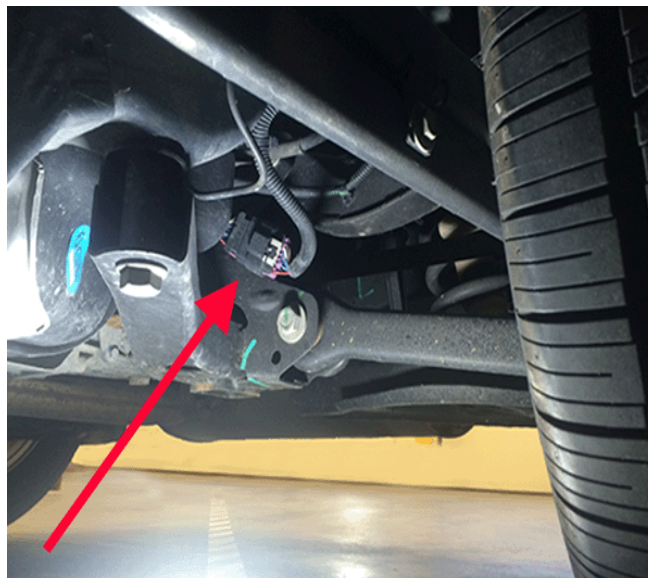
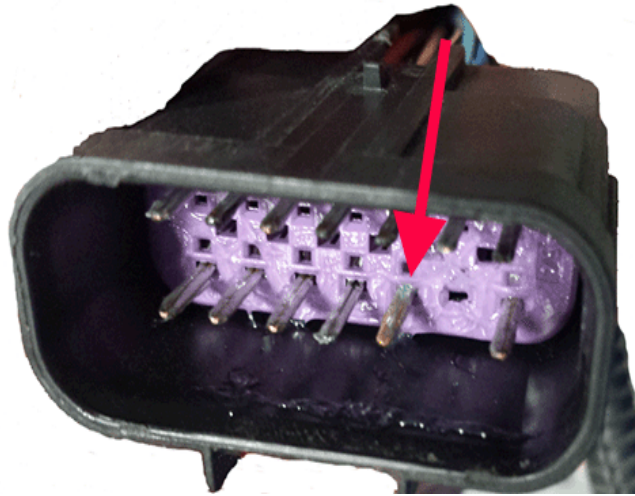
4205020

These concerns may be caused by corrosion in the X411 connector located under the rear of the vehicle, behind and to the left of the fuel tank.

To correct concern, please replace the appropriate terminals / connector at X411 as needed.
