MODEL
2011~2016MY
Optima Hybrid
(TF HEV)

NUMBER
PS391

OPTIMA HYBRID (TF HEV) WITH DTC B1695 - LOST
COMMUNICATION WITH E-COMP

GROUP TRA	MODEL 2014~2015MY Cadenza (VG)
	NUMBER 056	DATE August 2015
TECHNICAL SERVICE BULLETIN		
SUBJECT: TCM UPGRADE – SHIFT LOGIC IMPROVEMENT

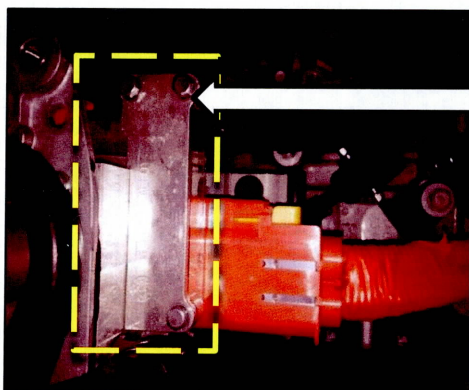
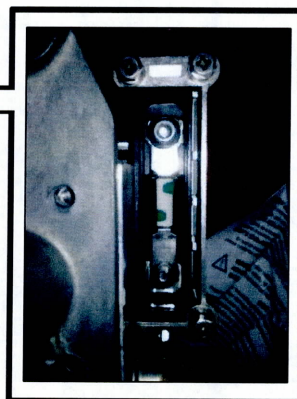
When addressing a customer concern related to an A/C system not blowing cold air and DTC B1695 is active in the A/C Control Unit, this could be the result of one, or more, of the following conditions:

- A blown High-Voltage (HV) fuse in the E-Comp 270 volt supply circuit.
- A circuit concern between the A/C Control Unit and the E-Comp
- A High-Voltage (HV) circuit concern

Begin the diagnosis process by locating the HV E-Comp fuse on the HPCU. The fuse is located at the rear of the unit just above the 270V input to the HPCU. Once the fuse is located, remove it and test for continuity across the fuse. If the continuity test reveals an open circuit, order a replacement fuse. **Note – If the fuse is blown, it is likely due to either a harness or an E-Comp concern. Verify the root cause before replacing the fuse or it will likely blow again. For additional diagnosis information, refer to the Service Information on KGIS.**
