Service Bulletin

Subject: Difficult to Shift into Gear, Intermittent Gear Pop Out and/or Mushy Shifts (No Grind)

Models: 2014-2015 Chevrolet Corvette
Equipped with 7 Speed Manual Transmission (RPO MEL, MEP, MEK)

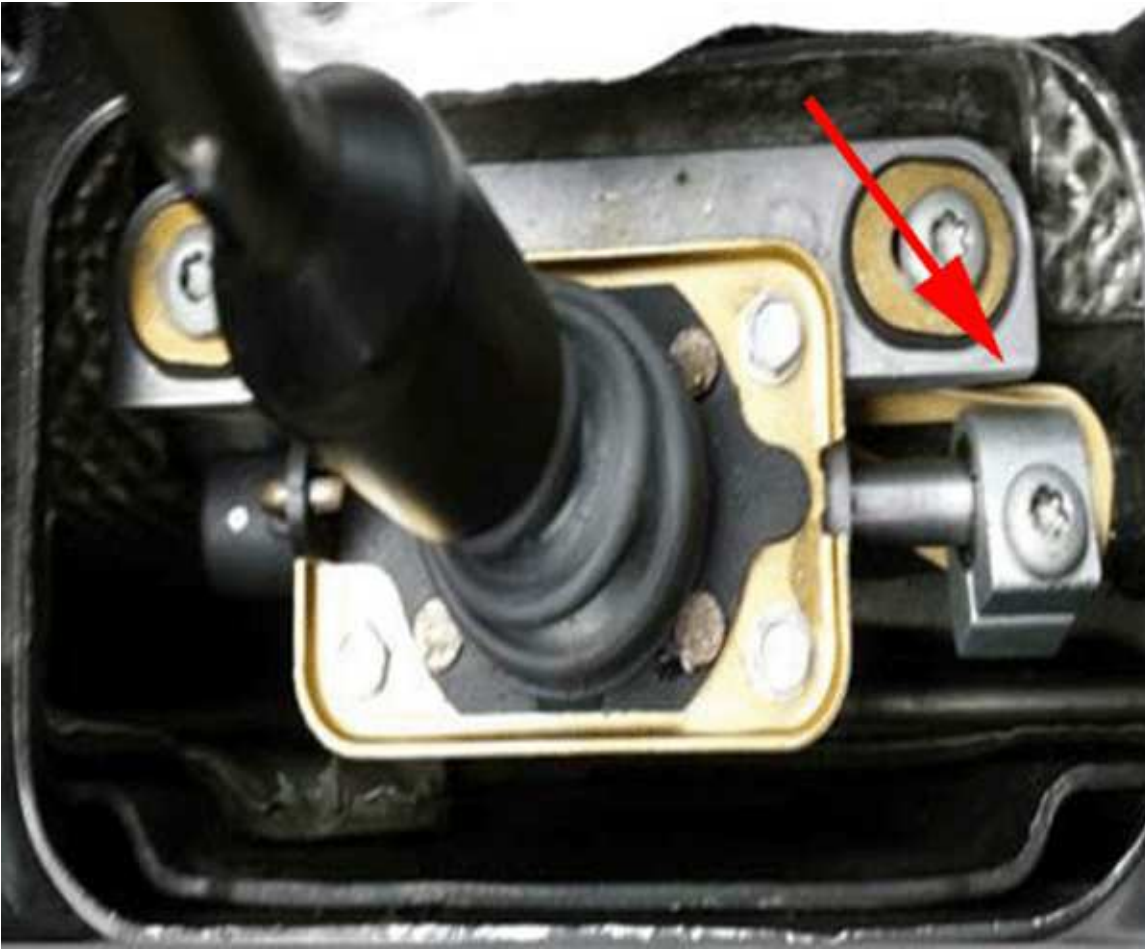
Note: There may be some variation on how and where the rubber band is placed. The above picture shows one possible location.

5. Before performing the shifter adjustment, make sure that the rubber band used to retain the shifter link during assembly is removed.

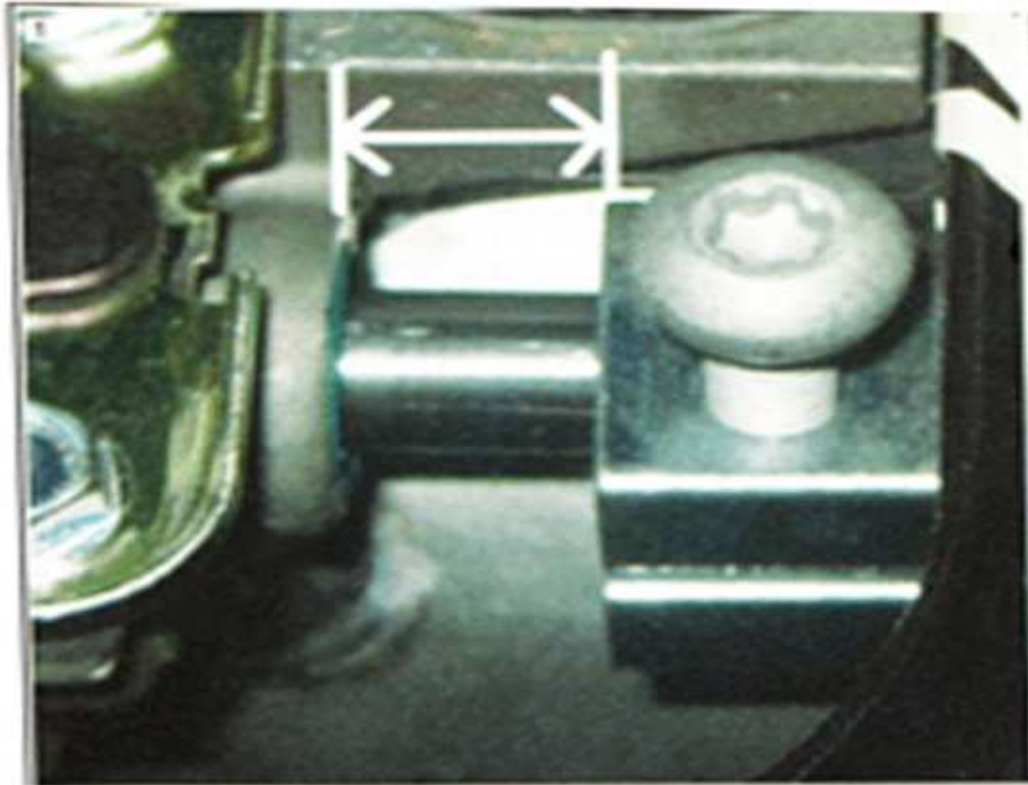
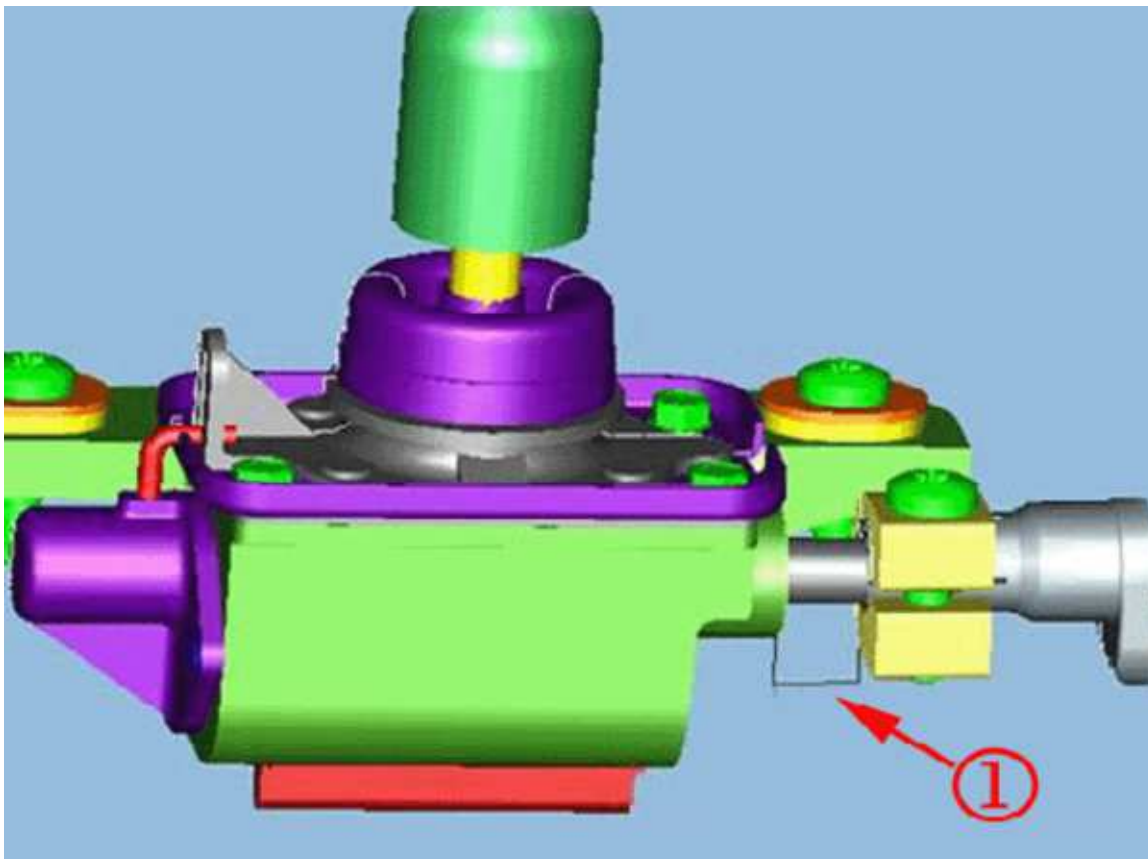
- 10.4.** Inspect for proper alignment in the Neutral position. When the shift rod clamp is properly positioned the bolt will engage the slot/relief in the shift rod and be positioned approximately 15 mm from the shifter assembly as shown above (1).
- 10.5.** Fix if incorrectly aligned by grabbing the linkage and push/pull to the proper gate.
