Service Bulletin

Subject: Engineering Information – Vehicle Pulls to One Side and/or Steering Feels Loose

Models: 2015-2016 Chevrolet Colorado
2015-2016 GMC Canyon

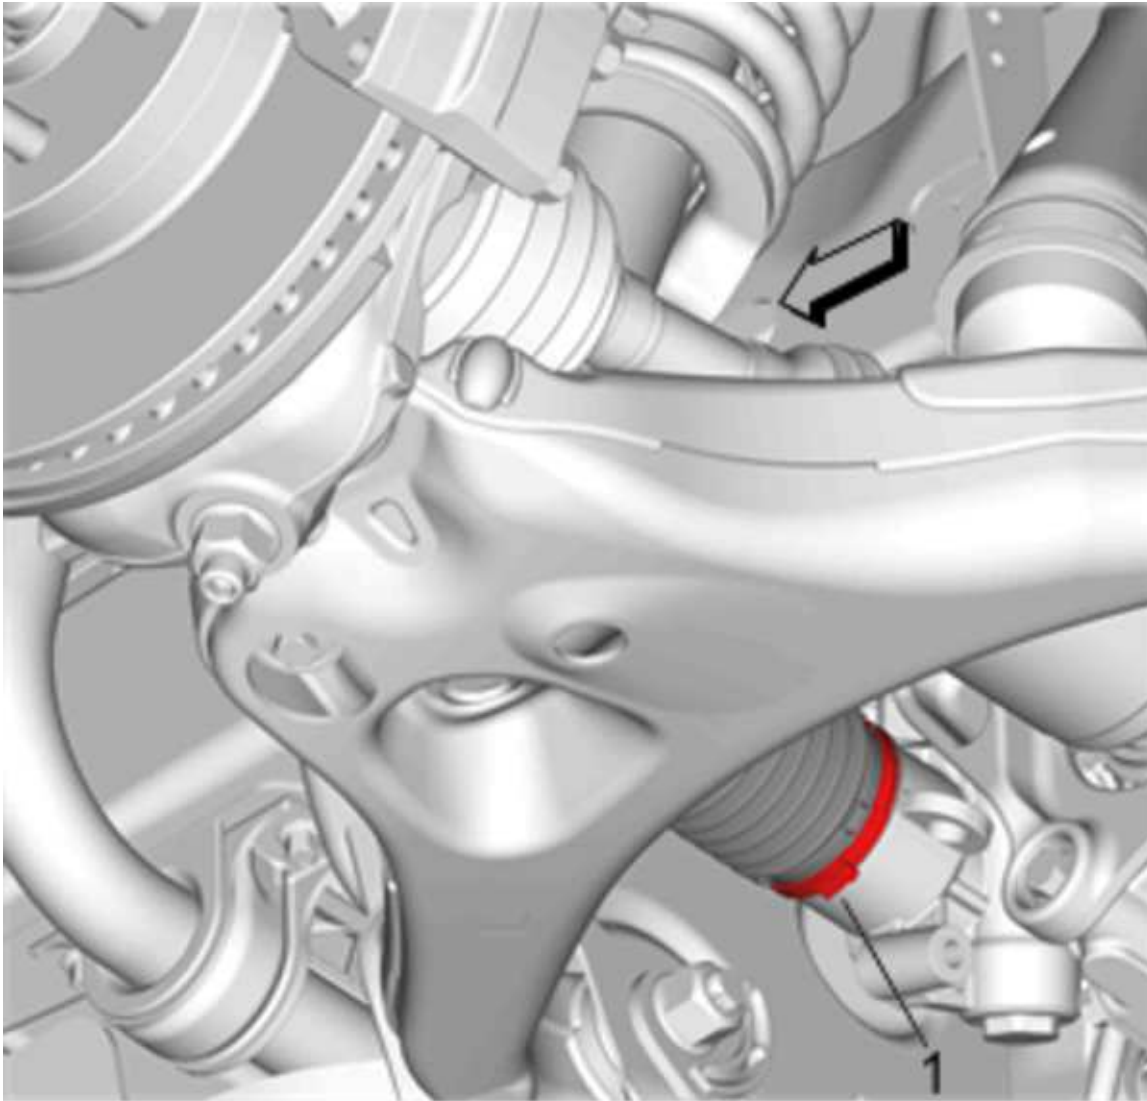
2. With the vehicle in full rebound and the wheel straight, remove the inner steering gear boot clamp (1). Refer to Steering Gear Boot Replacement in SI.
Note: The inner steering gear boot clamp will need to be replaced once removed.
3. With the boot pulled outward from the vehicle, visually inspect the following:
 - Which side of the vehicle is the inner tie rod loose on?
 - Is the tie rod making contact to the rim of the tie rod ball housing while turning the wheel fully to the left or the right ?
