Service Bulletin

Subject: Engine Replacement Recommendations HFV6 Gen 1 Only

Models: 2008-2016 Buick Enclave
2010-2016 Buick LaCrosse
2013-2015 Cadillac ATS
2016 Cadillac ATS-V
2007-2015 Cadillac CTS
2014-2016 Cadillac CTS V-Sport
2007-2010 Cadillac STS
2007-2016 Cadillac SRX
2013-2016 Cadillac XTS
2010-2015 Chevrolet Camaro
2012-2013 Chevrolet Caprice PPV
2012-2015 Chevrolet Captiva Sport
2015-2016 Chevrolet Colorado
2008-2016 Chevrolet Equinox
2012-2016 Chevrolet Impala Vin W
2014-2016 Chevrolet Impala Vin 1 (including Bi-fuel)
2008-2012 Chevrolet Malibu
2009-2016 Chevrolet Traverse
2007-2016 GMC Acadia
2015-2016 GMC Canyon
2010-2016 GMC Terrain
2008-2010 Pontiac G6
2008-2009 Pontiac G8
2008-2009 Pontiac Torrent
2007-2009 Saturn Aura
2008-2010 Saturn Vue
2007-2010 Saturn Outlook
Equipped with HFV6 Gen 1 engines including RPO codes LAU, LF1, LF3, LF4, LFR, LFW, LFX, LLT, LP1, and LY7

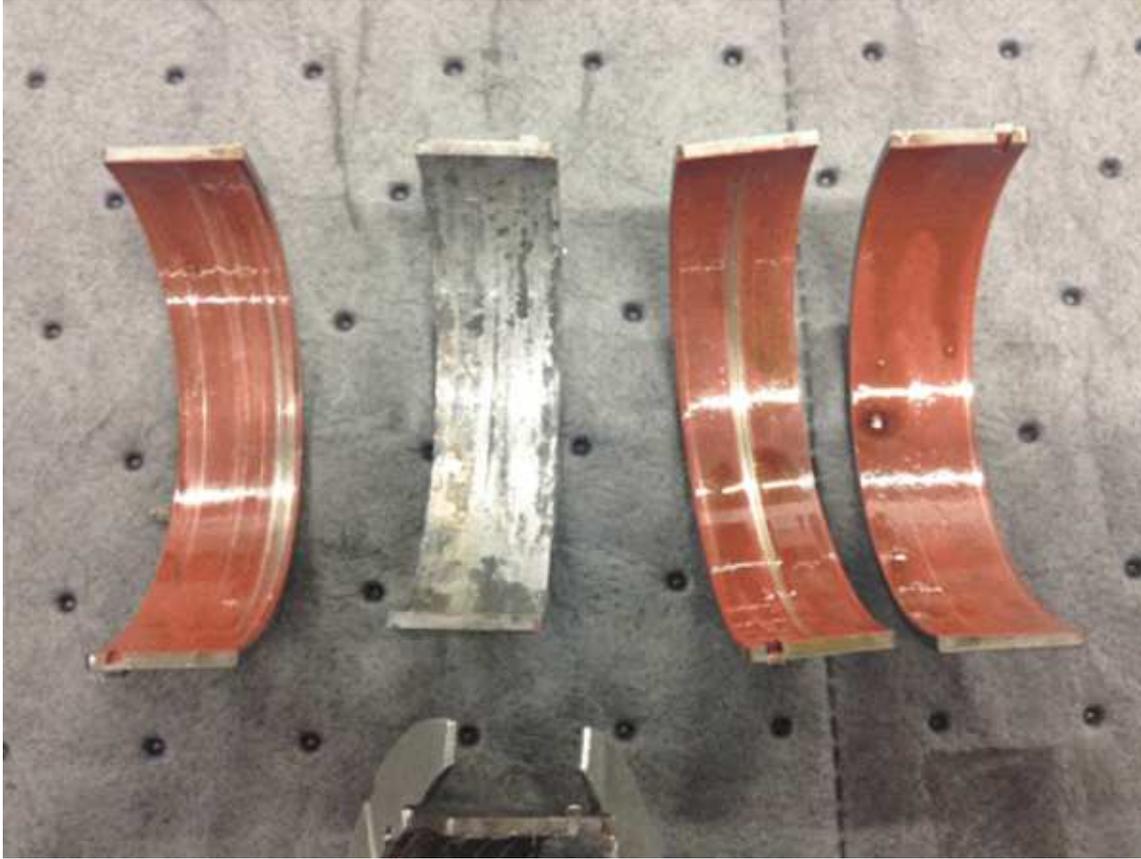
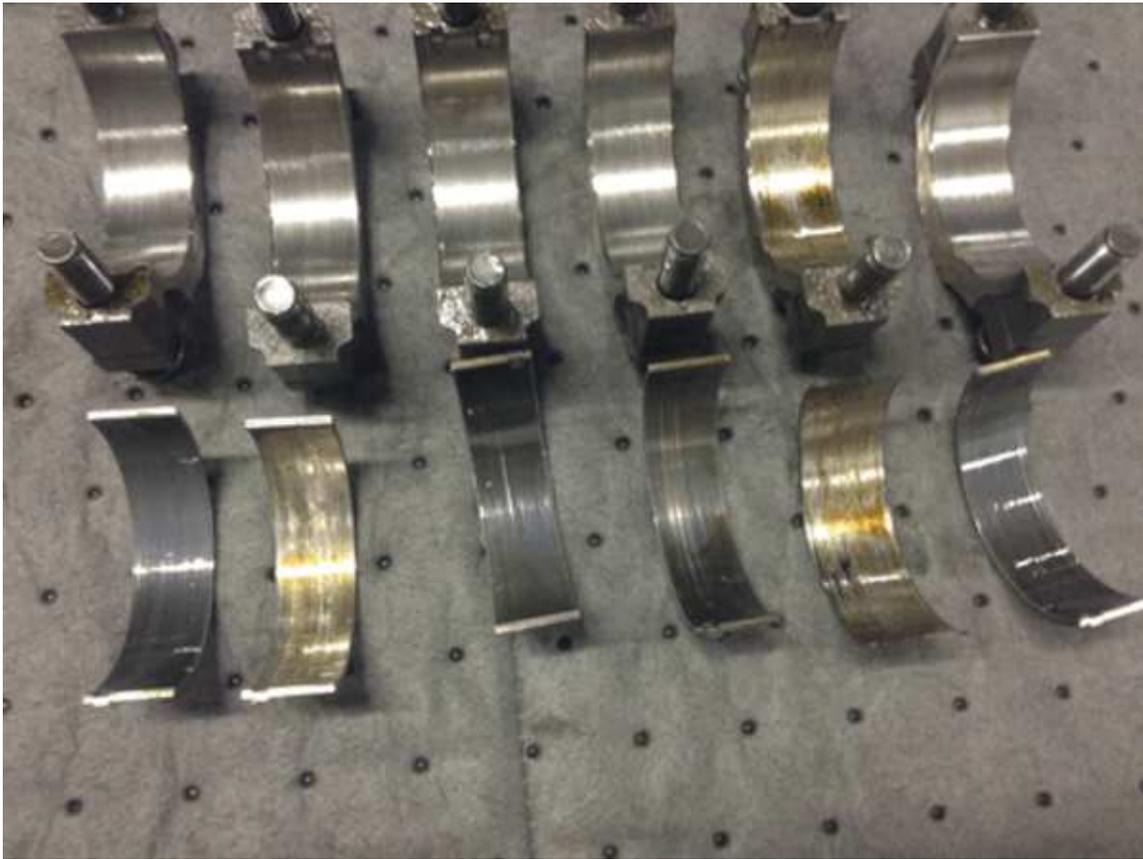
First, verify there is metal in the engine oil caused by BEARING DAMAGE / debris by removing the oil pan.

If Due To BEARING FAILURE when completing diagnosis, and deciding whether to replace the engine or repair it, complete the following before making that determination.

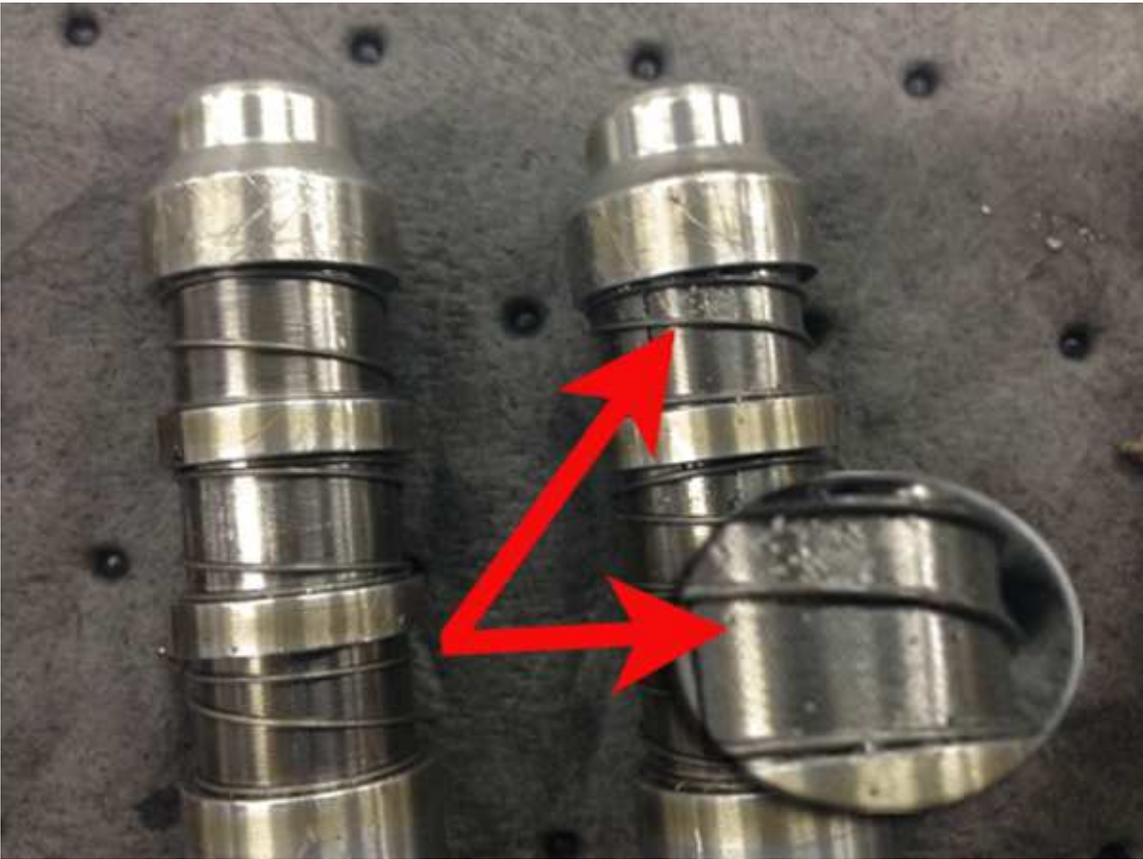
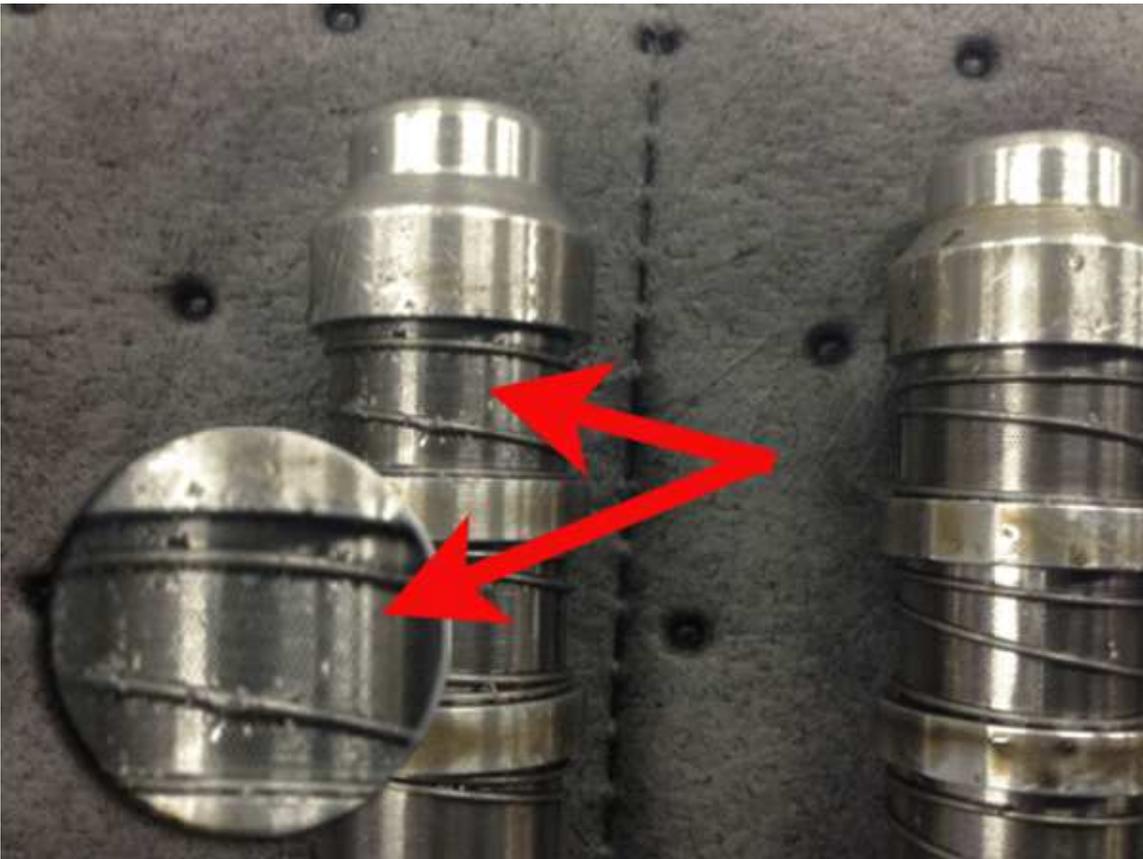
1. Inspect the oil control solenoids for metal debris. This shows the oil filter is in by-pass and unfiltered oil with bearing debris was pumped into the oil lubrication galleries, throughout the engine

Any Of These 3 instances would be cause to replace the engine instead of repair.

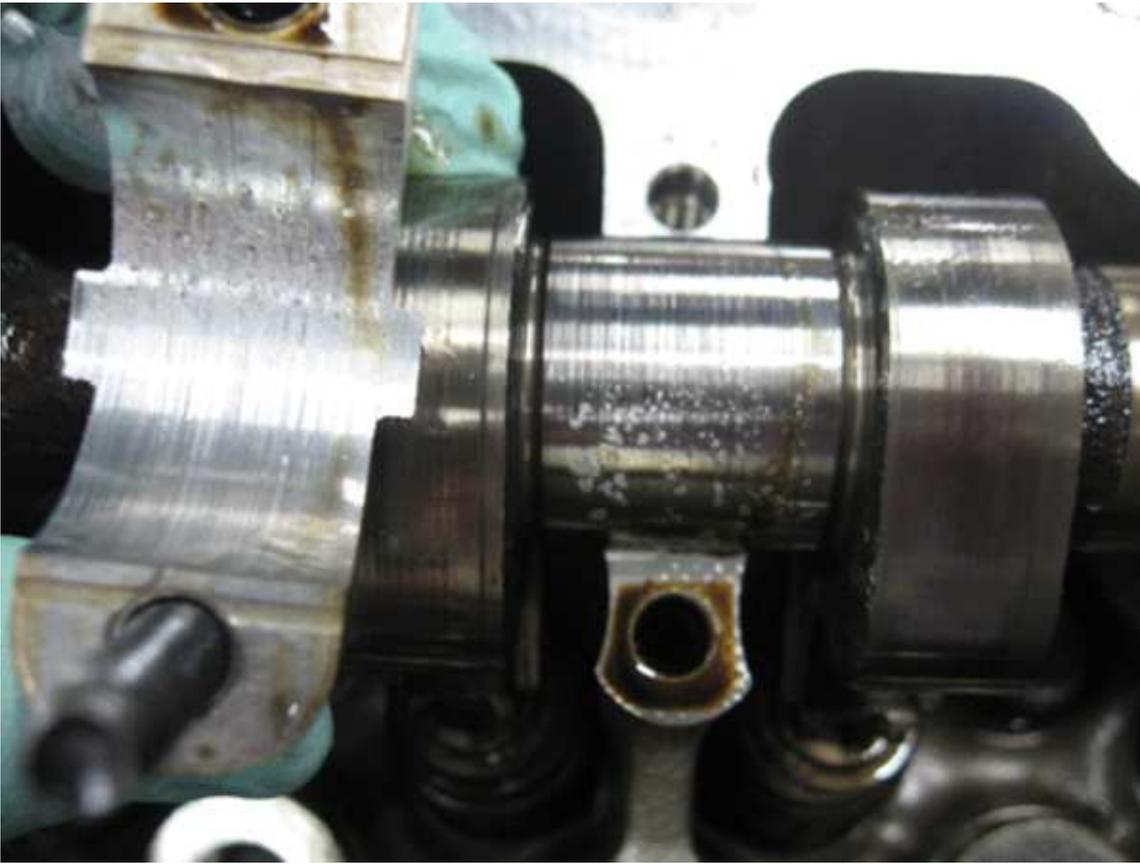
2. Inspect for damage to the cam caps Journals and camshaft journals on the heads (obvious signs of metal through the cap).

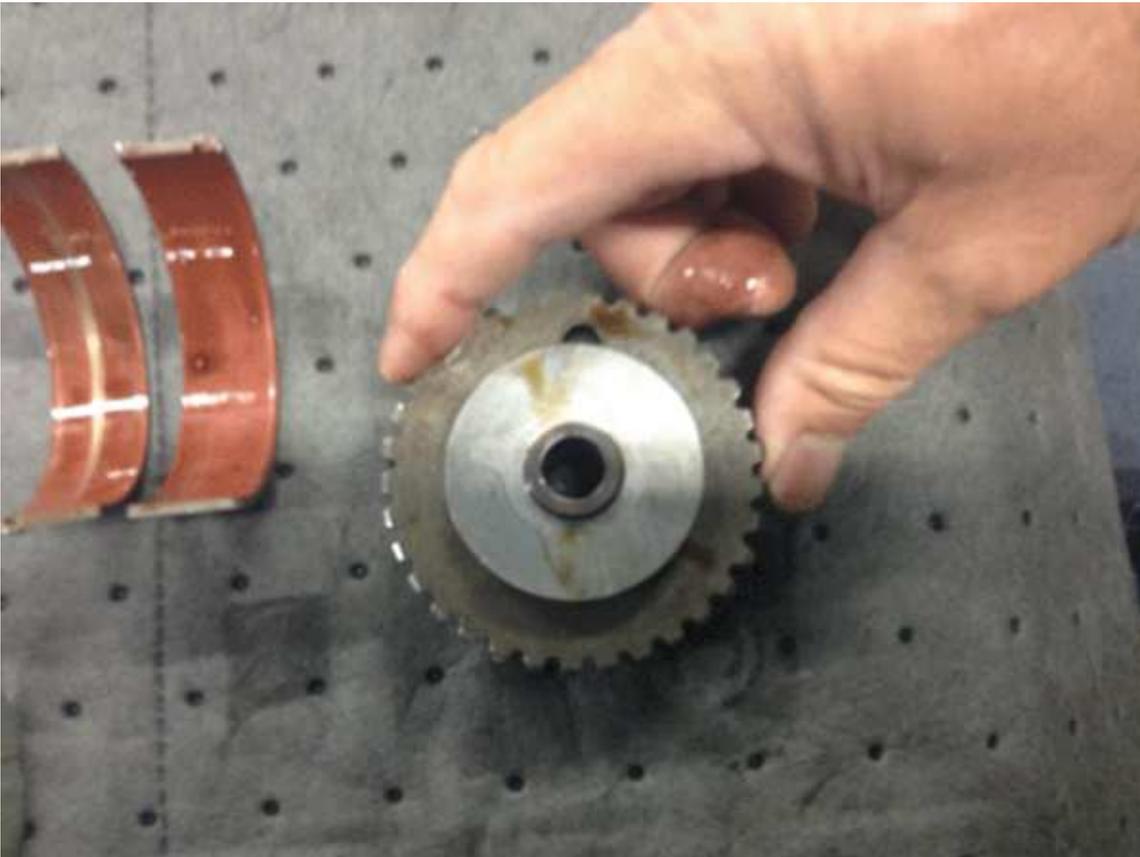
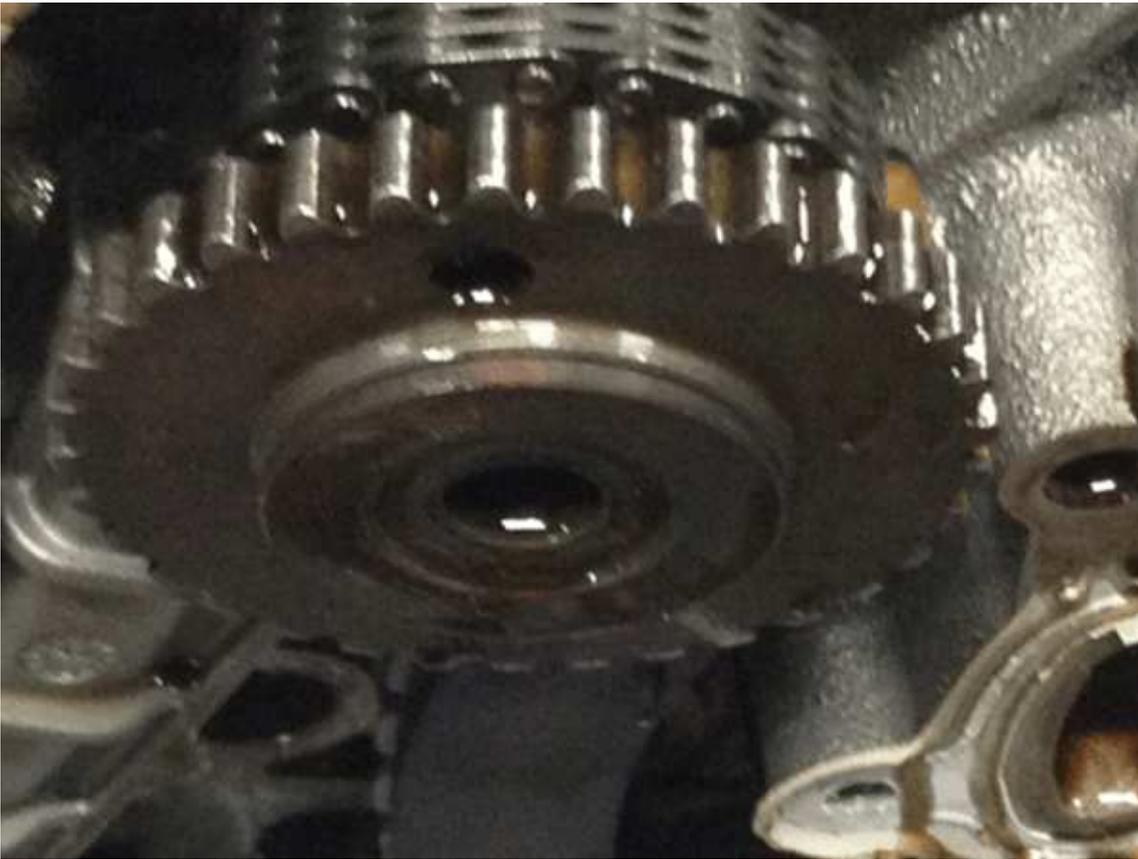
3. Inspect the timing chain idler sprockets for stiffness when turning. (Should turn smooth and free)
