## BOSCH HD10 ALTERNATOR CONNECTION INSPECTION

Prevost vehicles

On the vehicles affected by this bulletin, inspect the Bosch HD10 alternator connections.

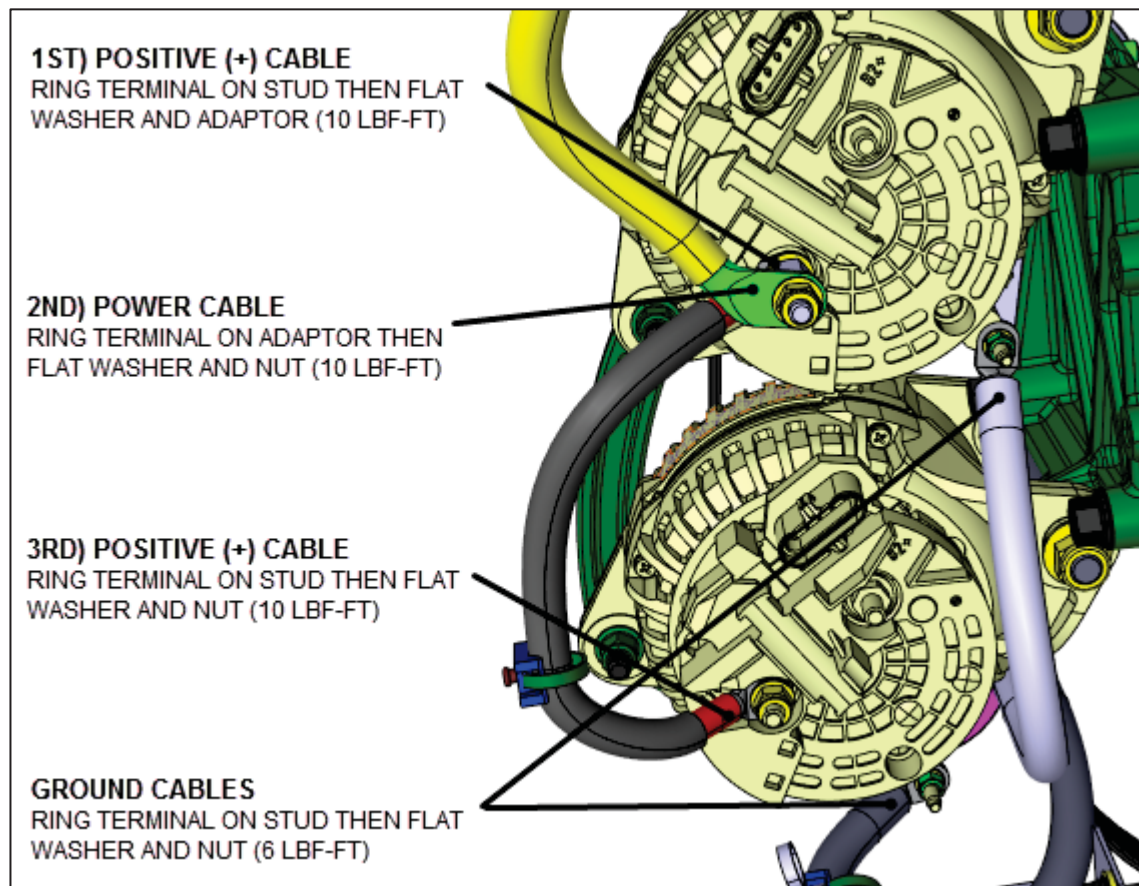
Figure 1

Upper and lower alternator torque reference, cable and hardware arrangement (Fig. 1).
