EGR TEMPERATURE SENSOR REPLACEMENT AND HARNESS ROUTING Prevost vehicles

For vehicles affected by this bulletin, eliminate connector pin movement and vibration by re-routing the temperature sensor engine harness lead. Also replace the EGR temperature sensor.

Special Bulletin

SP15-322A

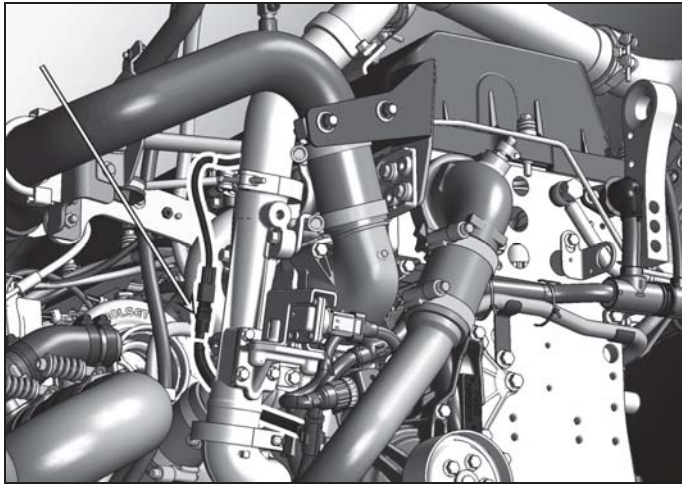
- 1) On the engine, road side, locate this branch of the engine harness.

Figure 1 Location on engine.

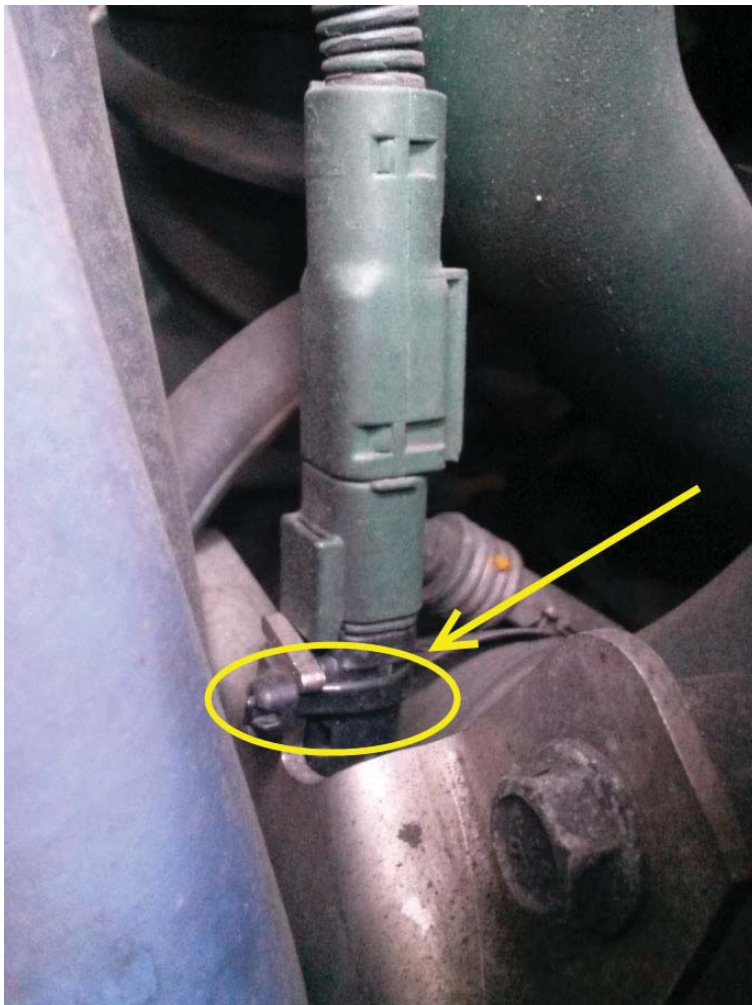
Figure 2: Original Routing.

- 2) Remove cable ties from harness.
