# Special Bulletin

# SP15-340

## SWAY BAR CLAMP HARDWARE REPLACEMENT

Prevost vehicles

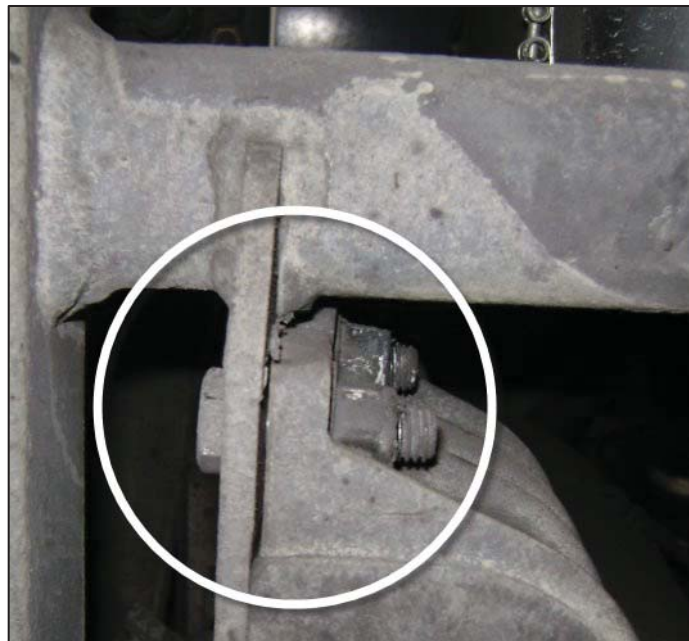
Figure 1

Make sure that there is no welding or gravel guard accumulation interfering with the contact surface. (the surface between the clamp base and structure) (Fig. 1)

1. On the front steer axle and on the rear drive axle, clean the sway bar clamps around the upper bolts.
2. Perform a thorough visual inspection of the contact surface between each sway bar clamp and the frame support.
