# Technical Service Bulletin

SUBJECT: <b>DEW CONDENSATION IN HEADLIGHTS AND TAILLIGHTS</b>			No: <b>TSB-15-54-005</b>
			DATE: <b>September, 2015</b>
			MODEL: <b>ALL</b>
CIRCULATE TO:	<input type="checkbox"/> GENERAL MANAGER	<input checked="" type="checkbox"/> PARTS MANAGER	<input checked="" type="checkbox"/> TECHNICIAN
<input checked="" type="checkbox"/> SERVICE ADVISOR	<input checked="" type="checkbox"/> SERVICE MANAGER	<input checked="" type="checkbox"/> WARRANTY PROCESSOR	<input type="checkbox"/> SALES MANAGER

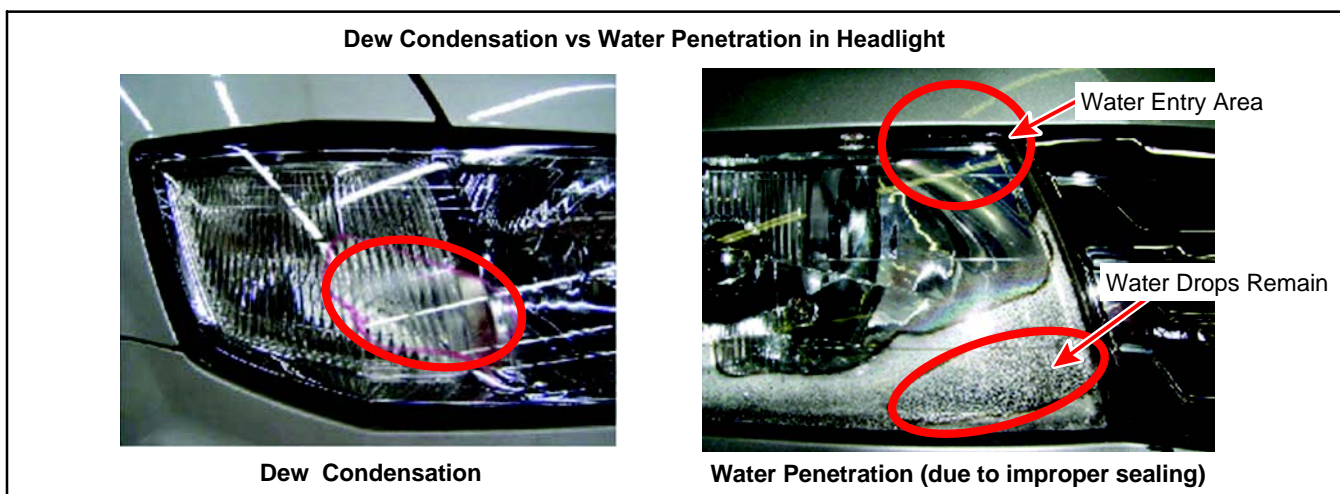
The two main causes of a fogged headlight or taillight are dew condensation or water penetration.

Dew condensation is a natural phenomenon and is **not** a part failure. It typically dissipates within one hour after lights have been on.

In contrast, water penetration may be caused by a part defect such as improper sealing, where water drops remain inside and do not dissipate after lights have been on for at least an hour. If water drops still remain inside the light after one hour, with lights being on, then water penetration can be suspected.

- If the condensation dissipates after the light has been on for one hour, do NOT replace the light assembly. Explain to the customer that this is normal dew condensation.
- If the condition is judged to be water penetration, and the moisture remains in the light after one hour of the light being on, then the light assembly may need to be replaced.

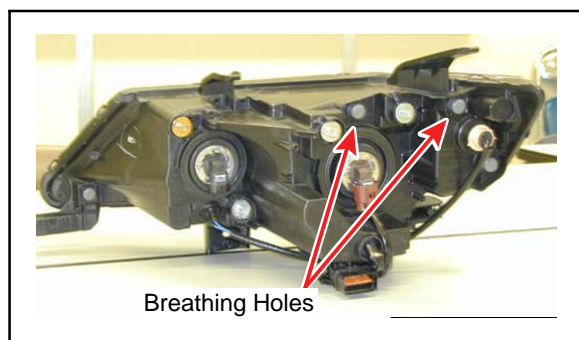
Headlights and taillights become fogged as part of a normal dew condensation process.

When the light is on, it generates heat, and air inside of the housing expands and contracts as the lights are turned on and off. The housing of headlights and taillights are designed with breathing holes that allow ambient air to flow into and out of the light housing. This design helps to prevent cracks and damage to the seal from pressure fluctuation.

When air outside of the light unit is humid, the moisture enters the light housing through the breathing holes as the light is turned on and off.

While some of the suctioned moisture dissipates, some of it stays inside the unit. In addition, resin materials of the light itself release moisture into the light unit as temperature rises. This warmer residual moisture becomes dew condensation when it contacts a cooler lens (for example, a lens that has been cooled by rain or washing the vehicle).

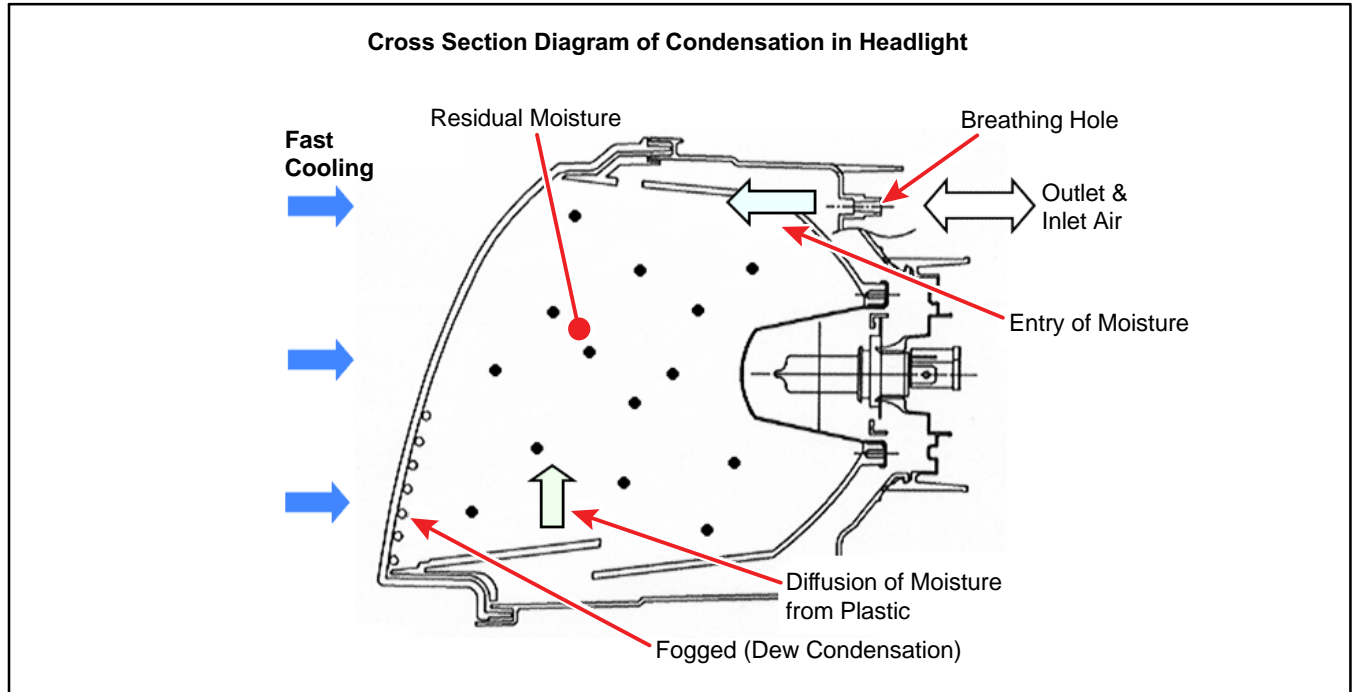
Dew condensation most often occurs in the following conditions:

- Extreme temperature differences
- After washing the vehicle
- Driving in the rain
- Sunlight hitting the light in cold ambient temperatures (e.g., morning sun in winter)
