Service Action

Code: 34G5

Subject	Automatic Transmission Fluid (ATF) Pipe Bracket
Release Date	December 17, 2015
Affected Vehicles	U.S.A. & CANADA: 2014-2015 MY Volkswagen Touareg 3.0L TDI <i>Check Campaigns/Actions screen in Elsa on the day of repair to verify that a VIN qualifies for repair under this action. Elsa is the <u>only</u> valid campaign inquiry & verification source.</i> <ul style="list-style-type: none">✓ Campaign status must show "open."✓ If Elsa shows other open action(s), inform your customer so that the work can also be completed at the same time the vehicle is in the workshop for this campaign.
Problem Description	Over time and in rare cases, vehicle and road vibrations can cause a small automatic transmission fluid (ATF) pipe leak to occur.
Corrective Action	Install a bracket on the ATF pipe to help prevent pipe vibration.
Parts Information	Parts will be allocated prior to campaign release and will be on Upper Order Limits. If allocated parts have been used and your dealership is at the weekly Upper Order Limit, submit requests for additional parts via email to vwoupperorderlimits@vw.com .

**Subject: Service Action 34G5 – Automatic Transmission Fluid (ATF) Pi

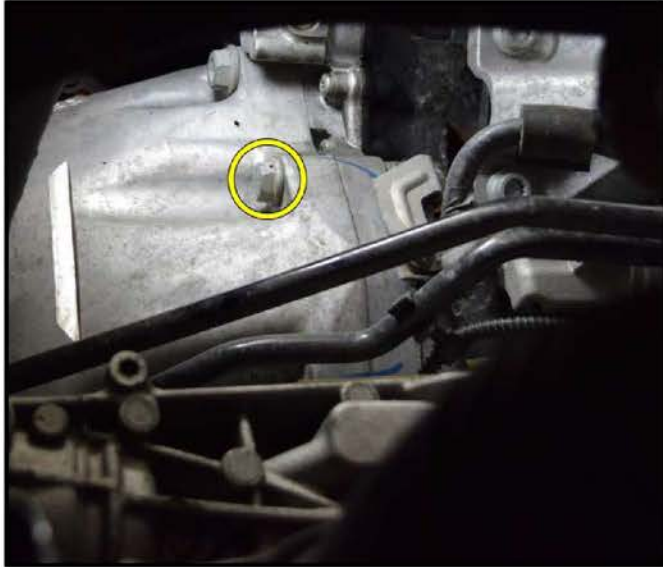
The transmission fluid lines and starter mounting bolt can be accessed through the right front lower wheel well area above the front differential <as shown>.

- Raise the vehicle on an appropriate hoist.
- With the vehicle slightly off the ground, turn the steering wheel all the way to the left.
- Raise the vehicle to a comfortable working height.
- Remove the starter mounting bolt <circle>.
