SERVICE CAMPAIGN BULLETIN

SUBJECT: POTENTIAL TRANSMISSION SHUDDER/SURGE – SERVICE CAMPAIGN			No: SC-15-003
			DATE: November, 2015
			MODEL: 2015 Outlander Sport/ RVR
CIRCULATE TO:	<input checked="" type="checkbox"/> GENERAL MANAGER	<input checked="" type="checkbox"/> PARTS MANAGER	<input checked="" type="checkbox"/> TECHNICIAN
<input checked="" type="checkbox"/> SERVICE ADVISOR	<input checked="" type="checkbox"/> SERVICE MANAGER	<input checked="" type="checkbox"/> WARRANTY PROCESSOR	<input checked="" type="checkbox"/> SALES MANAGER

Certain 2015 Outlander Sport/RVR vehicles with 2.0L engine and CVT-8 transmission built from June 25, 2014 to September 14, 2015.

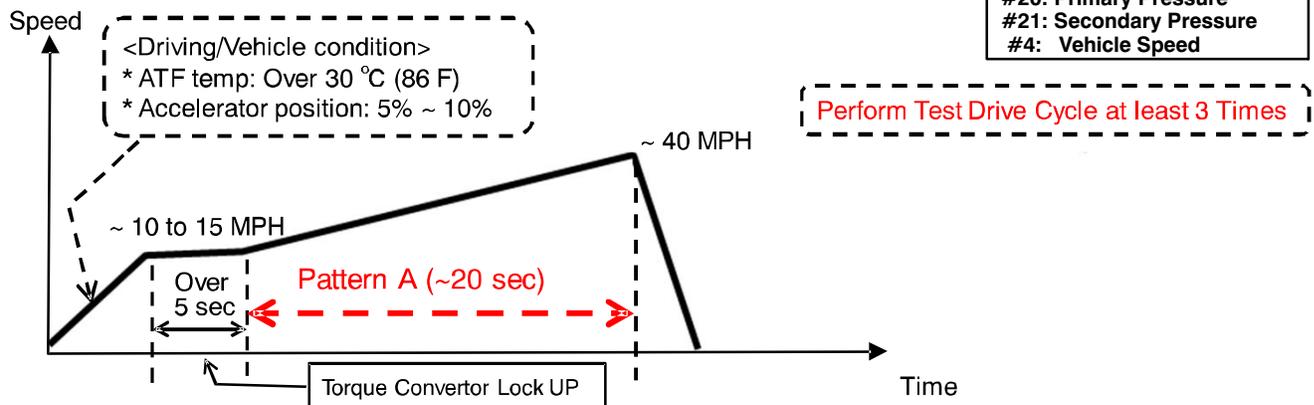
FIGURE 1. Test Drive Procedure for Duplicating CVT-8 Shudder

Condition	Driving Criteria	Judgment Criteria
Pattern A (Slow acceleration)	Shudder	<ul style="list-style-type: none"> Slow & gentle acceleration 10 to 40 MPH Constant acceleration Approximately 10% throttle angle Slight uphill grade or flat road 	<ul style="list-style-type: none"> Vehicle shuddering is felt Can be described also as a "bucking" Can also be described as a "judder" or repeated "jerking"

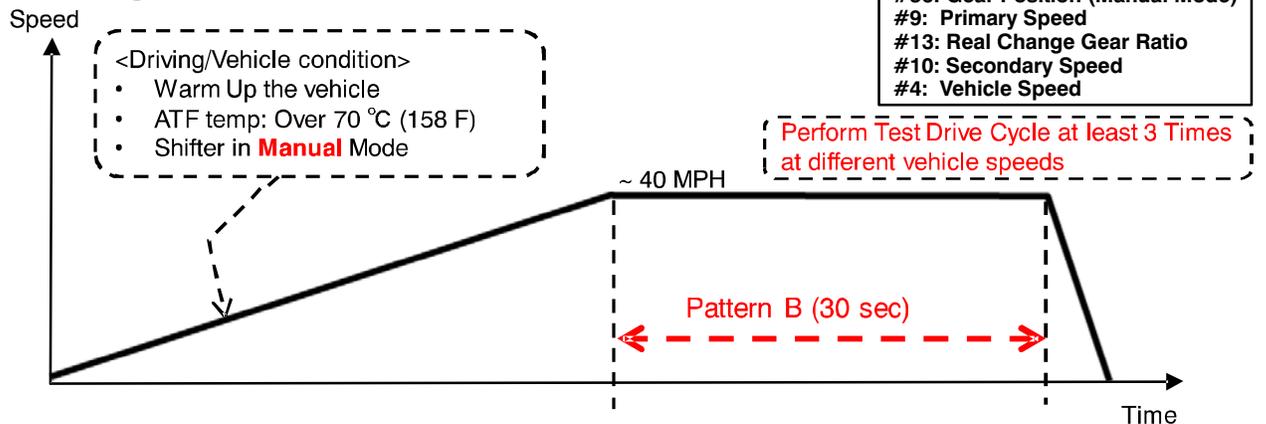
FIGURE 2. Test Drive Procedure for Duplicating CVT-8 Surge/Flare

Condition	Driving Criteria	Judgment Criteria
Pattern B (Constant Vehicle Speed)	Surge/Flare	<ul style="list-style-type: none"> Steady speed highway driving (follow all applicable laws) <ul style="list-style-type: none"> ~ 40 MPH ~ 50 MPH ~ 65 MPH ATF Temp > 158 F (warmed up) Shifter in Manual Mode 	<ul style="list-style-type: none"> Engine RPM surging or flaring (more than 200 RPM from base) at steady state vehicle condition
