Subject: BSM OFF INDICATOR ON WITH DTC U1A4B:97 OR U3000:97	Bulletin No: 15-002/15
	Last Issued: 12/10/2015

2016 MX-5 vehicles with VINs lower than JM1ND*****104338 (produced before August 20, 2015)

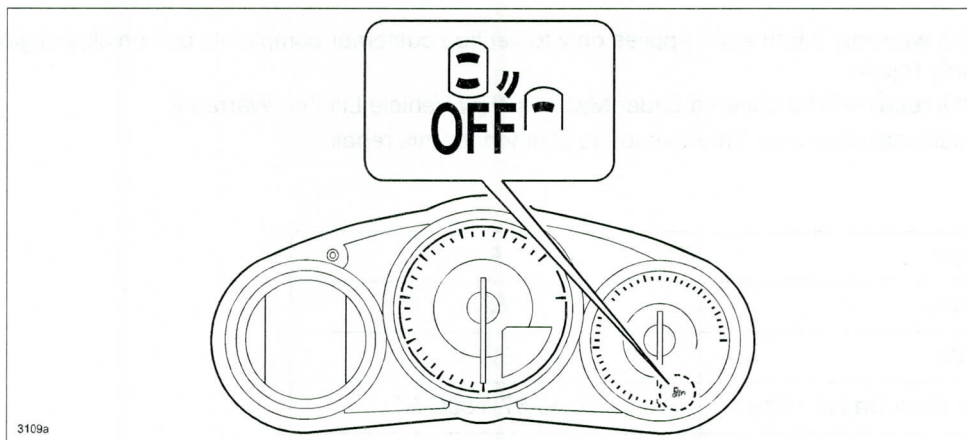
Some vehicles with Blind Spot Monitoring (BSM) may experience the following conditions (similar to when the BSM control modules detect dirt on the rear bumper surface):

- The BSM turns "OFF" and the BSM OFF indicator turns "ON" in the instrument cluster while driving
- The BSM will not turn on again during the drive cycle
- After cycling the ignition switch off and on again, the BSM operates normally
- DTC U1A4B:97 or U3000:97 is stored in memory
 - DTC U1A4B:97 - Radar sensor sensitivity temporarily decreases depending on various external and environmental factors (blind spot monitoring (BSM) control module (RH))
 - DTC U3000:97 - Radar sensor sensitivity temporarily decreases depending on various external and environmental factors (blind spot monitoring (BSM) control module (LH))

To correct this problem, the control logic of the BSM control modules has been changed.
