Service Bulletin

SUBJECT: Service Update for Inventory and Customer Vehicles
Power Liftgate Inoperable
Expires with Base Warranty

MODELS: 2015 Cadillac Escalade, Escalade ESV
2015 Chevrolet Suburban, Tahoe
2015 GMC Yukon, Yukon XL
Equipped with Power Liftgate (TB5/TC2)

Subject: 14300A Service Update
Power Liftgate Inoperable
Revised Service Procedure and Part Information

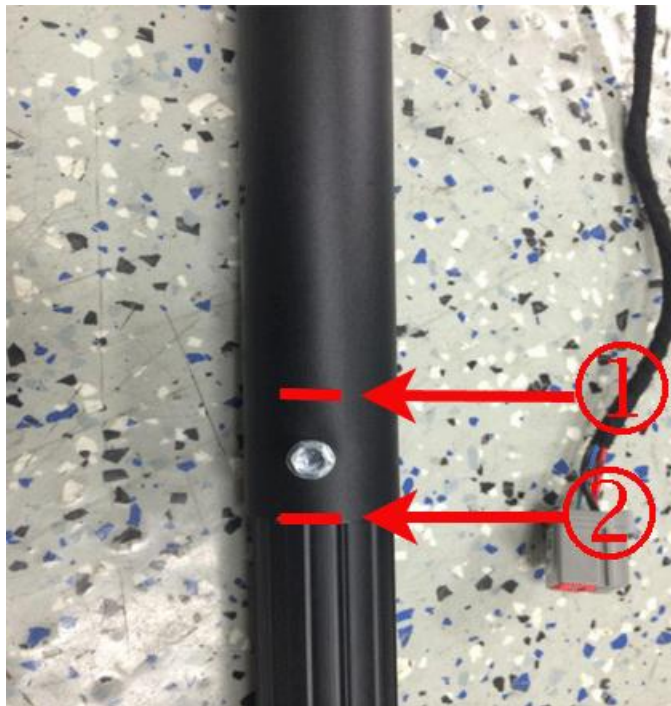
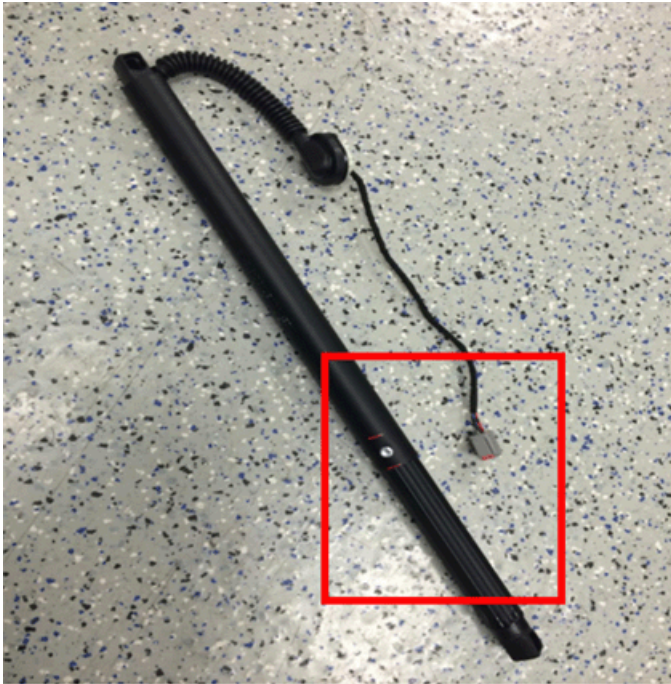
Note: The screw will hold the strut together for removal.

3. Install the self-tapping screw any place in the 30 mm space (from the bottom of the smooth tube) between location 1 and 2. As reflected above, a location of 20 mm (approximately 3/4") is ideal to secure the tubes.
