# Service Bulletin

**SUBJECT:** Service Update for Inventory and Customer Vehicles  
Power Steering Hose Leak  
Expires with Base Warranty

**MODELS:** 2015 Chevrolet Silverado 2500/3500 HD  
2015 GMC Sierra 2500/3500 HD  
Serviced Before September 9, 2014 (Pursuant to Recall Bulletin 14356)

Subject: 14608A – Service Update  
Power Steering Hose Leak  
Revised Parts Information

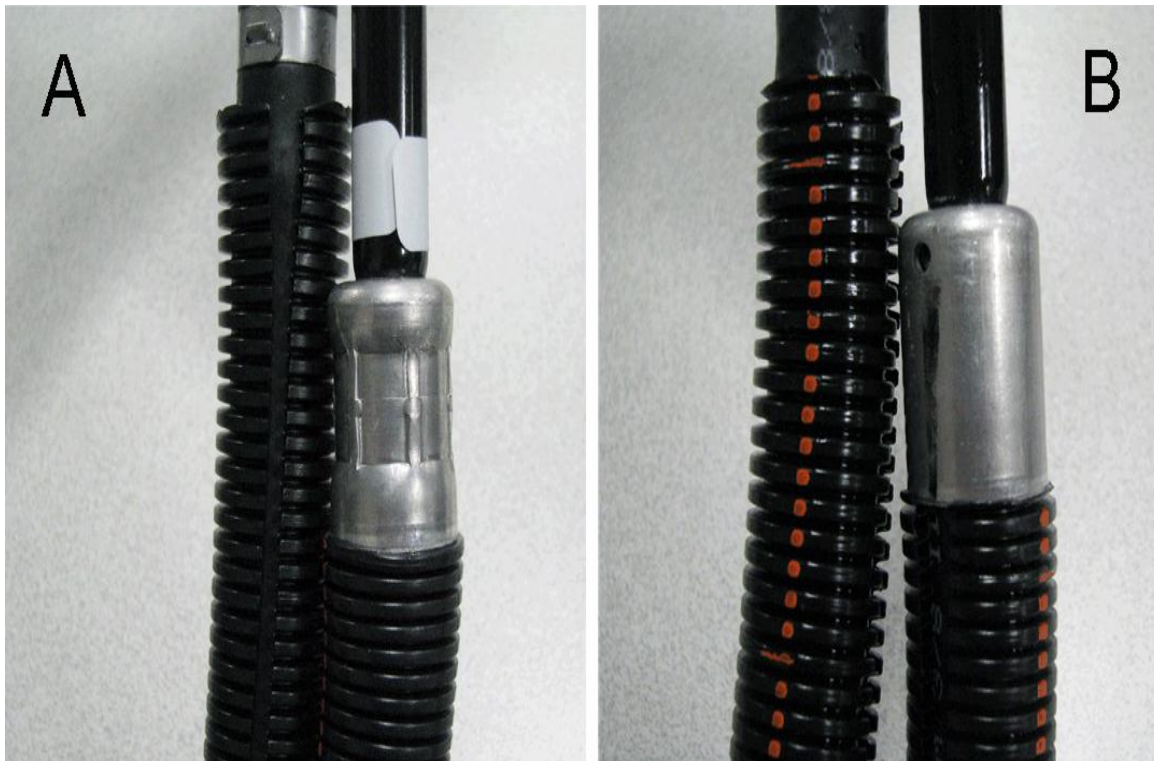
3975435

(A) Crimped ferrule with swedge marks. This is a secure connection on the pipe ferrule. (B) Uncrimped ferrule without swedge marks. This is NOT a secure connection on the pipe ferrule.

- If the power steering hose is missing a ferrule, the crimps are NOT secure or DO NOT show evidence of swedge marks, **replace the power steering fluid cooler**. Refer to *Power Steering Fluid Cooler Replacement (Heavy Duty)* in SI.

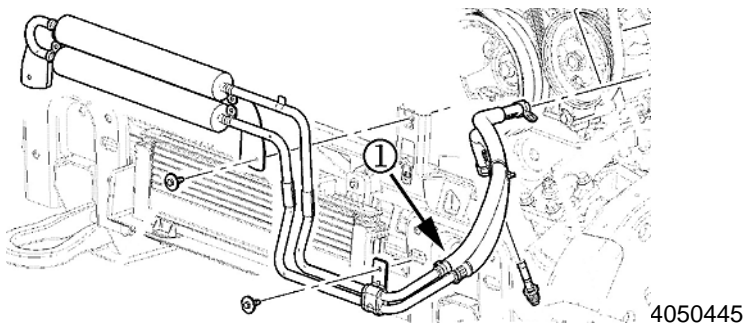
Gas engine shown – Diesel similar

1. Open the hood and locate the section of the power steering cooler lines where the rubber hoses join the metal pipes (1).
2. Verify there is a metal collar (ferrule) on the both rubber hoses where they join the metal pipes.

3. Verify that both ferrules are crimped and display the swedge mark. Pull on the crimped end of the hose to determine if hose crimp is loose (not secure) on the pipe ferrule.
