# Service Bulletin

**SUBJECT:** Special Coverage Adjustment – Ignition Key Removal

**MODELS:** 2005-2006 Chevrolet Equinox  
2006 Pontiac Torrent  
2005-2007 Saturn VUE

Subject: 14319 – Special Coverage Adjustment  
Ignition Key Removal

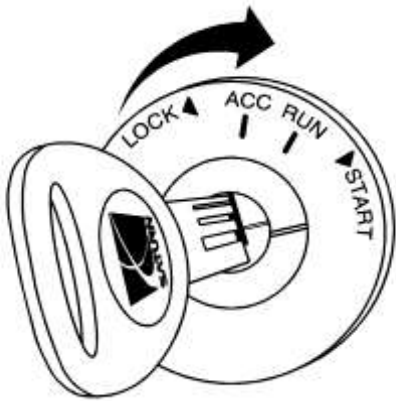
1334808

**Note:** Some Saturn VUE vehicles may have a condition in which the ignition key can be removed when the ignition is NOT in the LOCK position.

**Note:** With the key in the ignition switch, you can turn it to four different positions. **You should only be able to remove the key when the ignition is turned to the LOCK position.** Below is a description of the four ignition positions:

1. Determine if the key can be removed from the ignition cylinder in any position other than the LOCK position.
  - If the key **cannot** be removed in any position other than the LOCK position, no further action is required.
  - If the key can be removed from the ignition cylinder while in the ACC, RUN or START position, replace the ignition lock cylinder and key set (2 keys). Proceed to step 2.
2. Remove the ignition lock cylinder. Refer to *Ignition Lock Cylinder Replacement* in SI.
3. Install a new ignition lock cylinder. Refer to *Ignition Lock Cylinder Replacement* in SI.

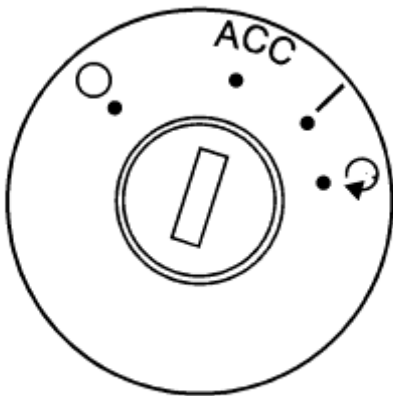
1839823

**Note:** Some Chevrolet Equinox and Pontiac Torrent vehicles may have a condition in which the ignition key can be removed when the ignition is NOT in the LOCK position.

**Note:** With the key in the ignition switch, you can turn it to four different positions. **You should only be able to remove the key when the ignition is turned to the LOCK position.** Below is a description of the four ignition positions:

1. Determine if the key can be removed from the ignition cylinder in any position other than the LOCK position.
  - If the key **cannot** be removed in any position other than the LOCK position, no further action is required.
  - If the key can be removed from the ignition cylinder while in the ACC, RUN or START position, replace the ignition lock cylinder and key set (2 keys). Proceed to step 2.
2. Remove the ignition lock cylinder. Refer to *Ignition Lock Cylinder Replacement* in SI.
3. Install a new ignition lock cylinder. Refer to *Ignition Lock Cylinder Replacement* in SI.
