Recall Bulletin

PRODUCT EMISSION RECALL

SUBJECT: Improperly Crimped Accelerator Pedal Position Electrical Terminals

MODELS: 2014 Cadillac ATS

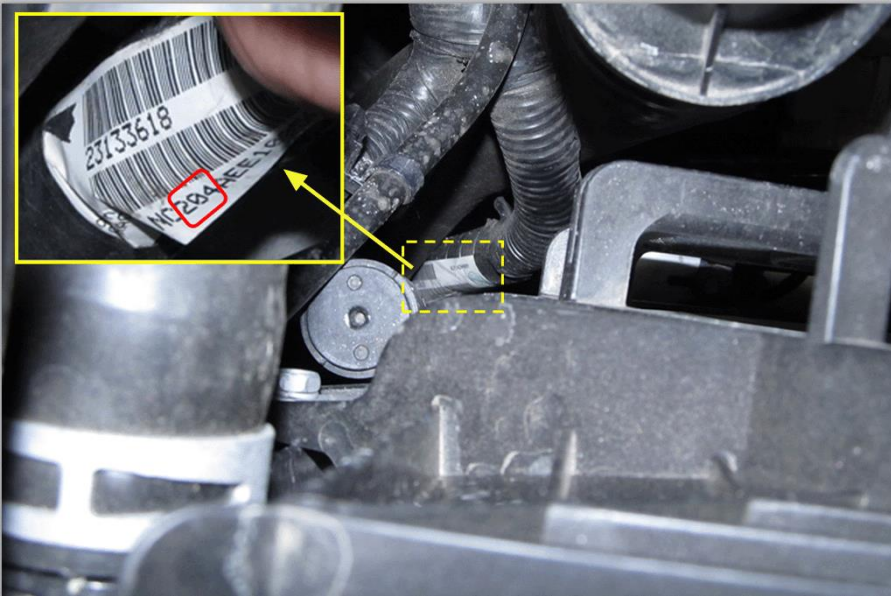
3942442

Tag and Date Code as Viewed from Top on a Four Cylinder Vehicle

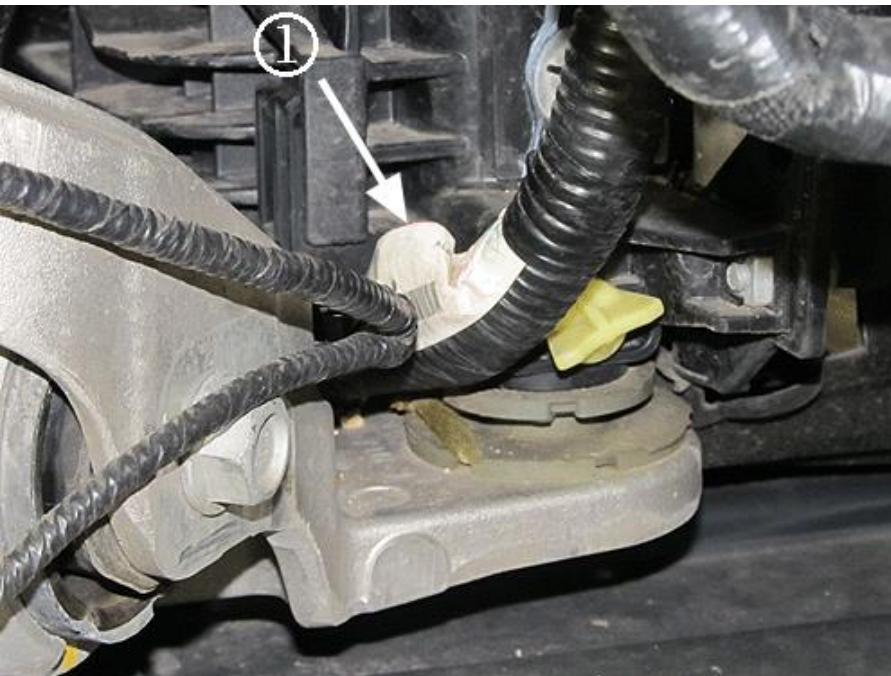
3942440

Tag (1) as Viewed from Bottom on a Six Cylinder Vehicle

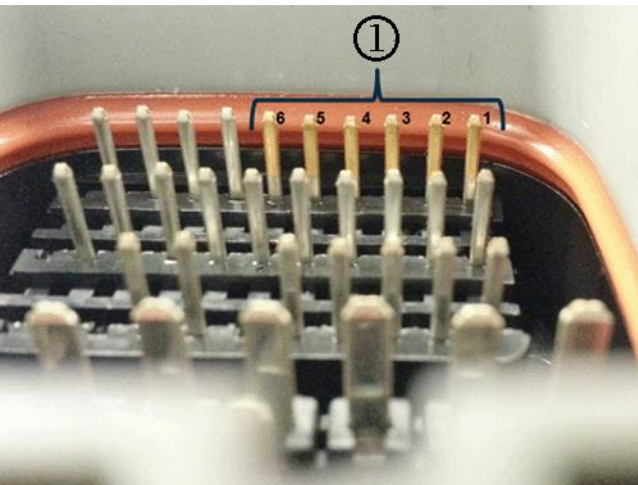
3942449

Caution: The Accelerator Pedal Position (APP) sensor circuits are cavities 1 through 6 within the X150 connector. All six terminals for APP must be gold plated.

7. Disconnect the connector and inspect the engine-side (male) terminals, 1 through 6 (1). As shown in the graphic above, the six terminals are gold and the surrounding terminals are tin.
 - If the Julian date code is **outside** the 182 – 187 range AND all six terminals are gold plated, no further action is required. Proceed to *Reassembly Procedure* below.

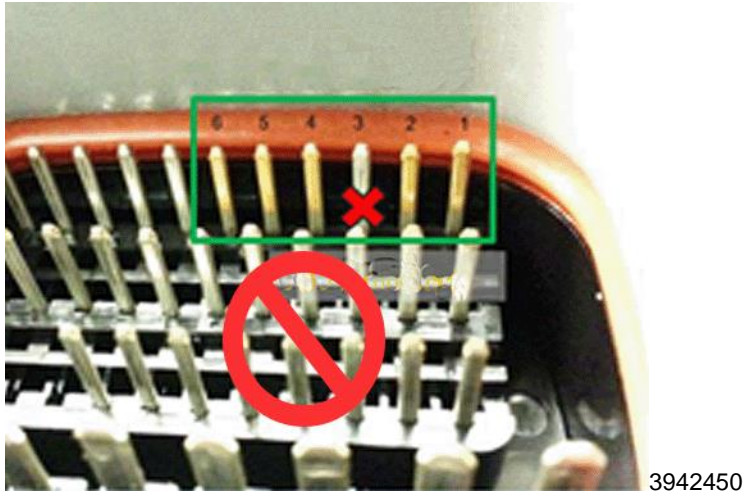
- If the Julian date code is **outside** the 182 – 187 range AND any tin plated terminals are found (like example shown in third terminal above), proceed to *Terminated Lead Replacement Procedure* below.
- If the Julian date code is **within** the 182 – 187 range AND all six terminals are gold plated, proceed to *Solder Terminal Crimps Repair Procedure* below.
- If the Julian date code is **within** the 182 – 187 range AND any tin plated terminals are found, solder the gold terminals and replace any tin terminals with a gold terminated lead. Follow first the *Terminated Lead* procedure, then the *Solder Terminal Crip* procedure below.
