Program Bulletin

CUSTOMER SATISFACTION PROGRAM

SUBJECT: Liftgate Strut Rod Detaches

MODELS: 2010-2015 Cadillac SRX
2011-2015 Chevrolet Volt

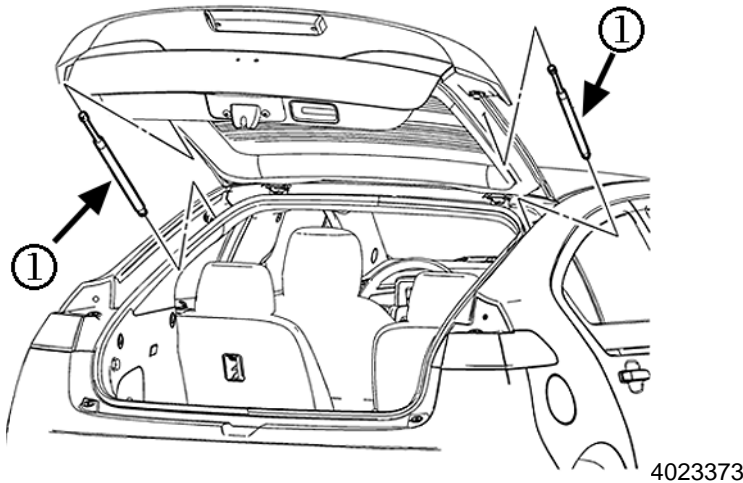
On certain 2010-2015 model year Cadillac SRX and 2011-2015 model year Chevrolet Volt vehicles, the manual liftgate gas strut may detach from the liftgate when the liftgate is closed and the piston rod could separate from the strut tube. If this occurs, the liftgate will not work and there may be damage to the liftgate exterior trim and sheet metal.

1. Remove the affected liftgate strut assembly (1). Refer to *Liftgate Strut Replacement* in SI.
2. Install the new liftgate strut assembly. Refer to *Liftgate Strut Replacement* in SI.
