Service Bulletin

SPECIAL COVERAGE

SUBJECT: Special Coverage Adjustment – Excessive Engine Oil Consumption

**MODELS: 2010 Chevrolet Equinox
2010 GMC Terrain
Equipped with 2.4L Engine (LAF)**

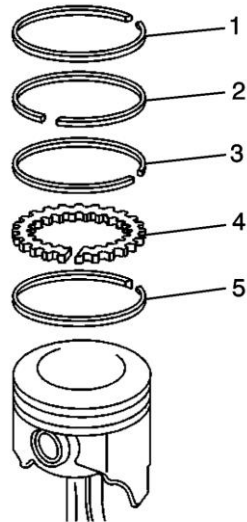
2146346

Note: The repair is to replace the pistons and rings. In some cases the bore surface may not have a uniform look to the finish (zebra stripes) as shown in Technical Service Bulletin 13-06-01-003F. As a result, some technicians may question whether the engine should be repaired or replaced. After careful evaluation, GM Powertrain has determined that the new pistons and rings will perform correctly in bores that have this appearance so engine replacement should not be necessary. The cylinder bores do not need any machine or honing work performed on them. Refer to Technical Service Bulletin 13-06-01-003F for more information.

- Engine Replacement
 - Technical Service Bulletin 13-06-01-003F
 - Piston and Connecting Rod Disassemble
 - Piston and Connecting Rod Assemble
 - Piston, Connecting Rod, and Bearing Installation (LAF, LAT, LE5, LE9, LEA, or LUK)
1. Remove the engine from the vehicle.
 2. Remove the pistons from the engine.
 3. Remove the pistons from the connecting rods.
 4. Discard the pistons and piston rings.
 5. Install the new piston rings onto the new pistons.
 6. Install the new pistons onto the connecting rods.
 7. Assemble the engine.
 8. Install the engine into the vehicle.
