APPLICABILITY: 2015MY WRX 2.0L DIT Models

NUMBER: 07-88-15

SUBJECT: SOA821B200 Replacement Battery Installation Procedure

DATE: 01/20/15

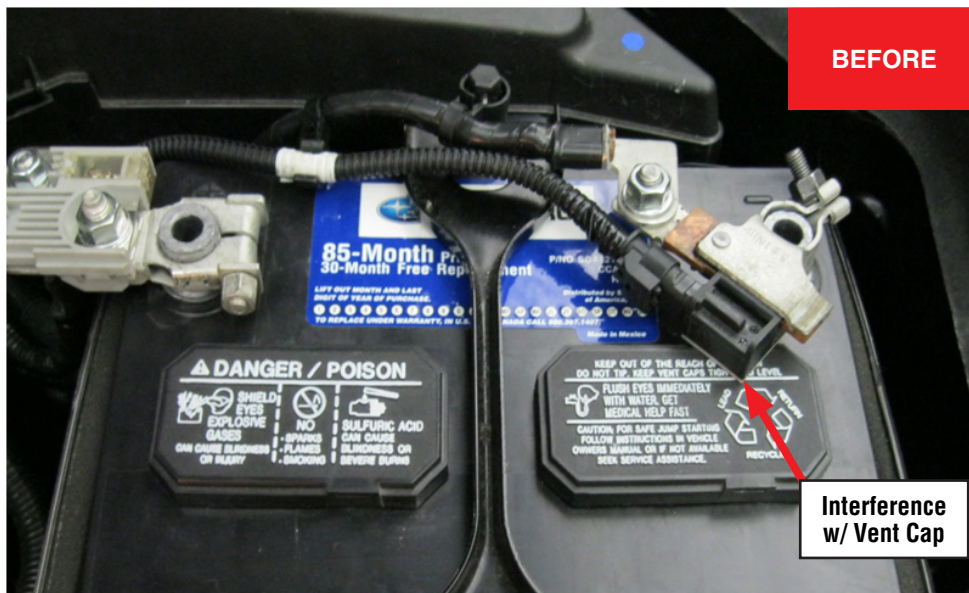
This Service Information bulletin provides a procedure to use when installing a SOA821B200 replacement battery in a 2015MY WRX (2.0L). The sensor located on the battery ground terminal interferes with the battery vent cap used on the replacement battery in the “BEFORE” photo below.
