**SERVICE BULLETIN**

**APPLICABILITY:** 2015MY Legacy and Outback Models  
**SUBJECT:** Fuel Filler Door Difficult to Open or Close

**NUMBER:** 09-60-15  
**DATE:** 01/14/15

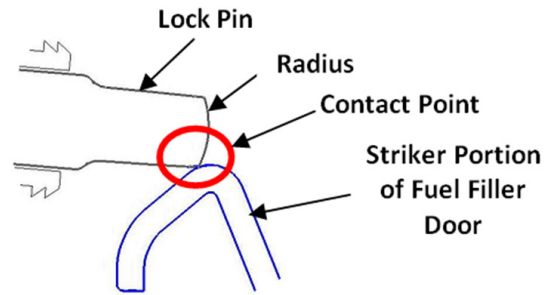
This bulletin provides a repair procedure to address a customer concern of the fuel filler door being difficult to open or close. The procedure involves removing approximately 1mm of material from the end of the plastic locking pin portion of the fuel filler door latch mechanism.

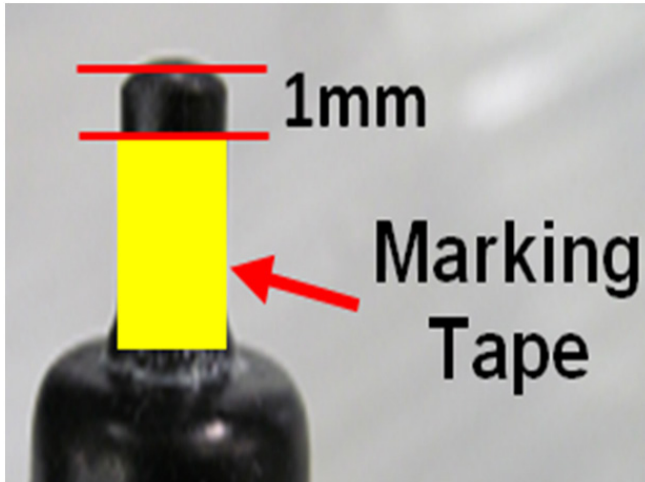
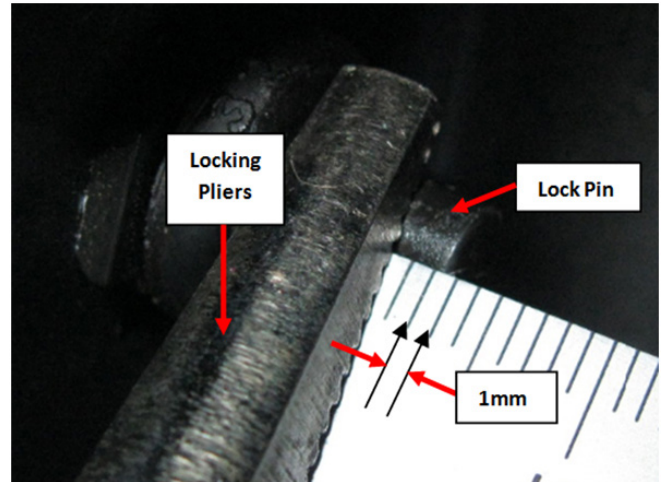
This procedure involves **CAREFULLY** filing off 1mm of material from the end of the plastic lock pin. Once the pin has been shortened, the radius shown in the illustration below must be restored onto the end of the lock pin for proper operation and contact with the striker.

- Open the fuel filler door and wipe any grease from the lock pin.
- Using a small ruler as reference, determine how much material needs to be removed to shorten the lock pin by 1mm. Use tape (eg. a thin piece of electrical tape) as a “guide” to indicate how much needs to be removed as shown below. The electrical tape also serves to help protect the lock pin from damage by the pliers. Look at the radius (curvature) on the end of the lock pin as this will need to be recreated once the 1mm of material is removed.
