## PRODUCT CAMPAIGN BULLETIN

**APPLICABILITY:** 2003-2005 Subaru Legacy and Outback  
 2003-2005 Subaru Baja  
 2004-2005 Subaru Impreza  
 (including WRX and STI)

**NUMBER:** WQM-49R

**SUBJECT:** Regional Front Passenger Air Bag Inflator Replacement

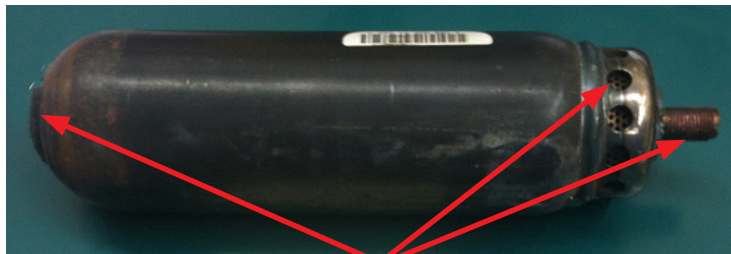
The shape, holes, and copper-colored stud indicate this not a Genuine Subaru inflator.

- Document the presence of the aftermarket or counterfeit device on the repair order and with photos. Report this information immediately on a Quality Monitoring Report (QMR).

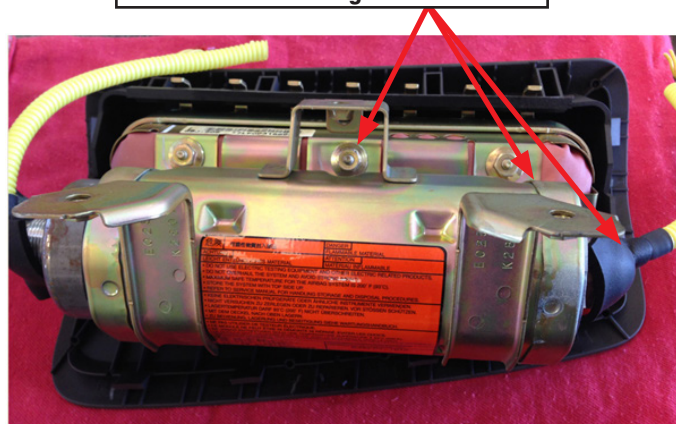
No visible stopper plates, a 6-nut configuration and rubber harness boots are other examples to indicate this is not a Genuine Subaru airbag module.
