Diagnostic Trouble Codes (DTCs), Low Oil Pressure
CXU, GU, LEU, MRU
MP7 US2010, OBD2013, US2014, OBD2015

FSB 221-010, Diagnostic Trouble Codes (DTCs), Low Oil Pressure

(August 2015)

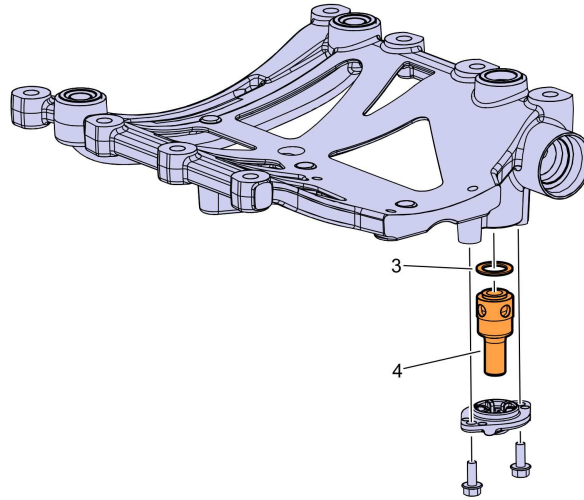
W2084376

During long hard pull conditions, diagnostic trouble codes (DTC) SPN 100 FMI 1 or P052400 can log, or engine shut down may occur on certain high mileage MACK CXU, GU, LEU and MRU vehicles built between January 1, 2010 and April 2, 2015 with MP7 engines. These DTC may occur during the conditions described in this bulletin, with or without an engine shut down lamp.

If there are no obvious signs of oil dilution, replace the pressure reduction valve, oil cooler and piston cooling nozzles using the procedure below. Also reprogram the engine control module if required based on the table below.

Item Number	Part Number	Description	Quantity
3	469846	O-Ring, Internal	1
4	22416685	Pressure Reduction (Relief) Valve, Purple	1
