# Field Service Bulletin Trucks

Engine Harness Repair  
MP7 US2015  
CXU, GU, LEU, MRU

## FSB 373-022, Engine Harness Repair

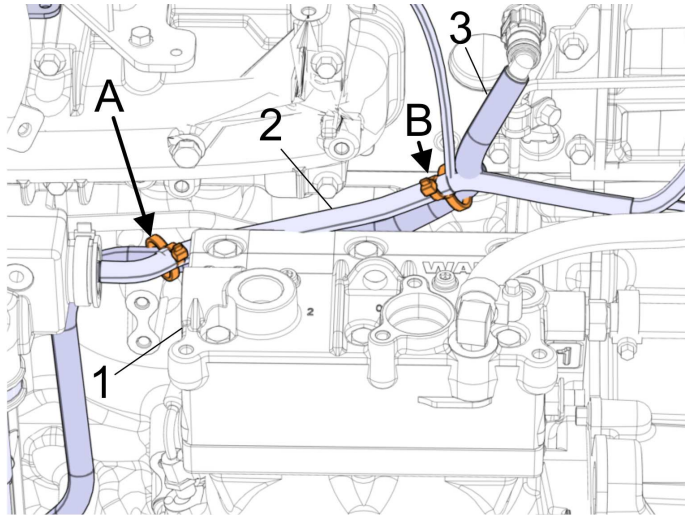
W3107068

The engine harness on MACK MP7 US2015 engines built between March 1, 2015 and August 31, 2015 may be making contact with the air compressor head and rubbing through. When diagnostic trouble codes (DTC) P0201 to P0206 FMI 13 are logging, look in this area first. If this is found to be the root cause of the DTC, it is recommended that the harness be repaired using a splice kit. On reassembly, protect and support the harness in this area.

20 Relocate the engine harness (2) and install double tie retainers (part number 20885496) as shown (A and B) to secure harness to cylinder head fuel line (3) between the air compressor and the engine block. Ensure harness is not touching air compressor. Make sure the ties are snugged tight.
