MP7 345R Throttle Delay at Cold Start LEU, MRU

FSB 284-062, MP7 345R Throttle Delay at Cold Start

(July 2015)

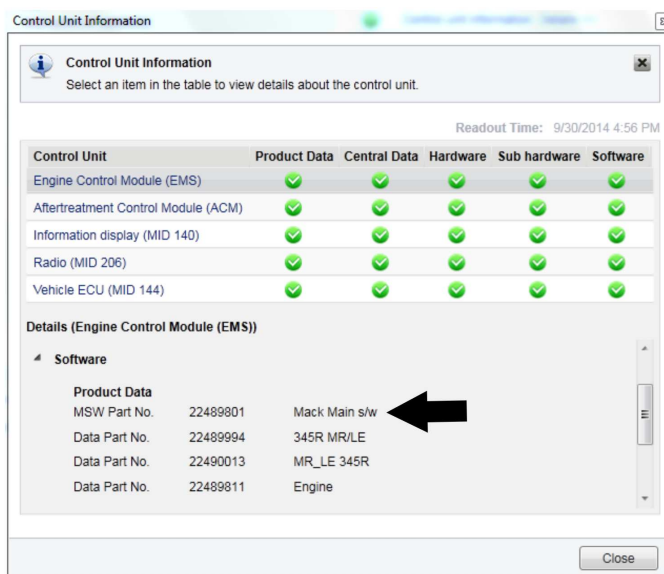
W2102733

If a chassis is experiencing the throttle delay as described in this bulletin, check the software level in the engine control module (ECM). Check for engine main software part number as shown below and compare to the table information.

Refer to service information in Function Group 284 to reprogram the engine control module (ECM).
