## Coolant Level Sensor, Replacement MRU, LEU, LR

### FSB 386-009, Coolant Level Sensor, Replacement

(May 2015)

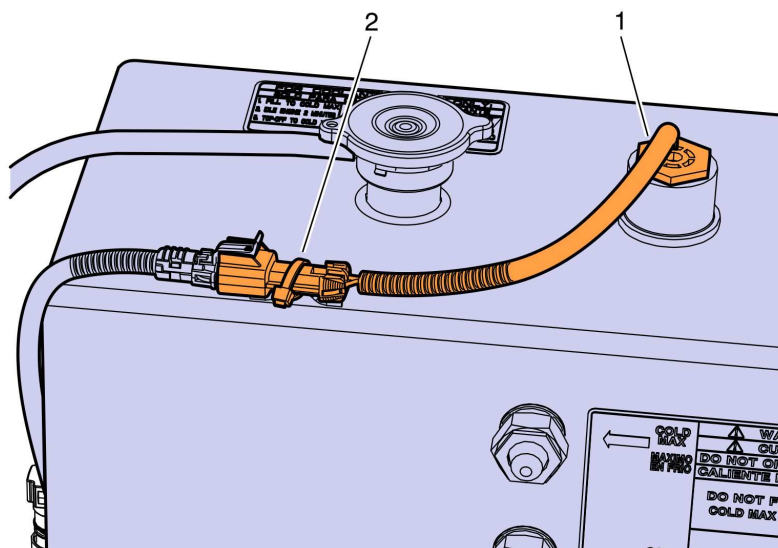
W3094949

The coolant level sensor (part number 21257608) on some MACK cabover trucks built between 10/04/2008 and 02/20/2015 may fail internally. Failure of the sensor can cause the malfunction indicator light (MIL) to illuminate and can cause an unplanned stop in cases where the engine parameter "engine shutdown with low coolant" is enabled. To prevent further issues with false low coolant warnings, replace the coolant sensor with part number 22312907.
