## High Soot Output MP7, MP8, MP10, US2014, OBD2015 CHU, CXU, GU, LEU, MRU, TD

### FSB 284-057, High Soot Output

(May 2015)

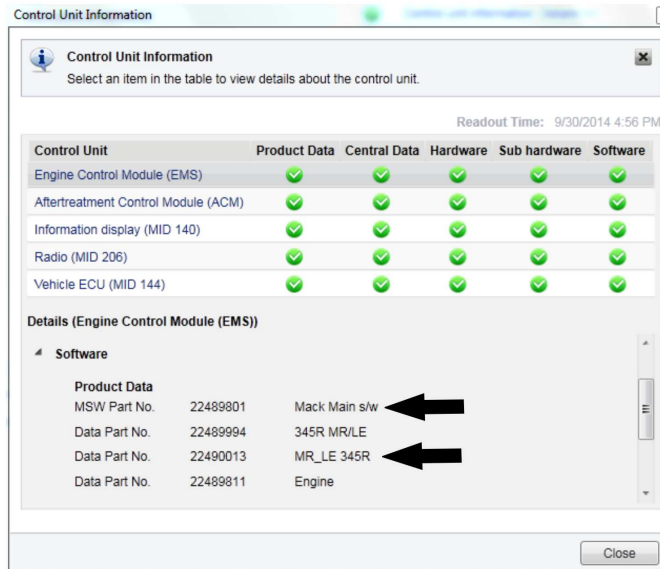
W2101882

If a chassis is being operated in cold climate conditions and is experiencing the hard start and rough idle on startup, check the software level in the engine control module (ECM). Check for engine data part number as shown below and compare to the table information.

Data Part Number	US2014	22561635 or less	Proceed with software update
		22652626 or higher	Open an eService and report the issue
Main Software Part Number	OBD2015	22616343 or less	Proceed with software update
		22644017 or higher	Open an eService and report the issue

Data Part Number	US2014	22560893 or less	Proceed with software update
		22652644 or higher	Open an eService and report the issue
Main Software Part Number	OBD2015	22573276 or less	Proceed with software update
		22644041 or higher	Open an eService and report the issue

Data Part Number	US2014	22572319 or less	Proceed with software update
		22665162 or higher	Open an eService and report the issue
Main Software Part Number	OBD2015	22644017 or less	Proceed with software update
		22687466 or higher	Open an eService and report the issue
