REFERENCE:	Nova Bus Manuals
SECTION:	12: Interior Furnishings
RS N°:	MQR 7621-849
EFFECTIVE IN PROD.:	N/A

SUBJECT:	Bum rest shells replacement
JUSTIFICATION:	Bum rest shells cracking and anchor points may loosen with time and vibration.

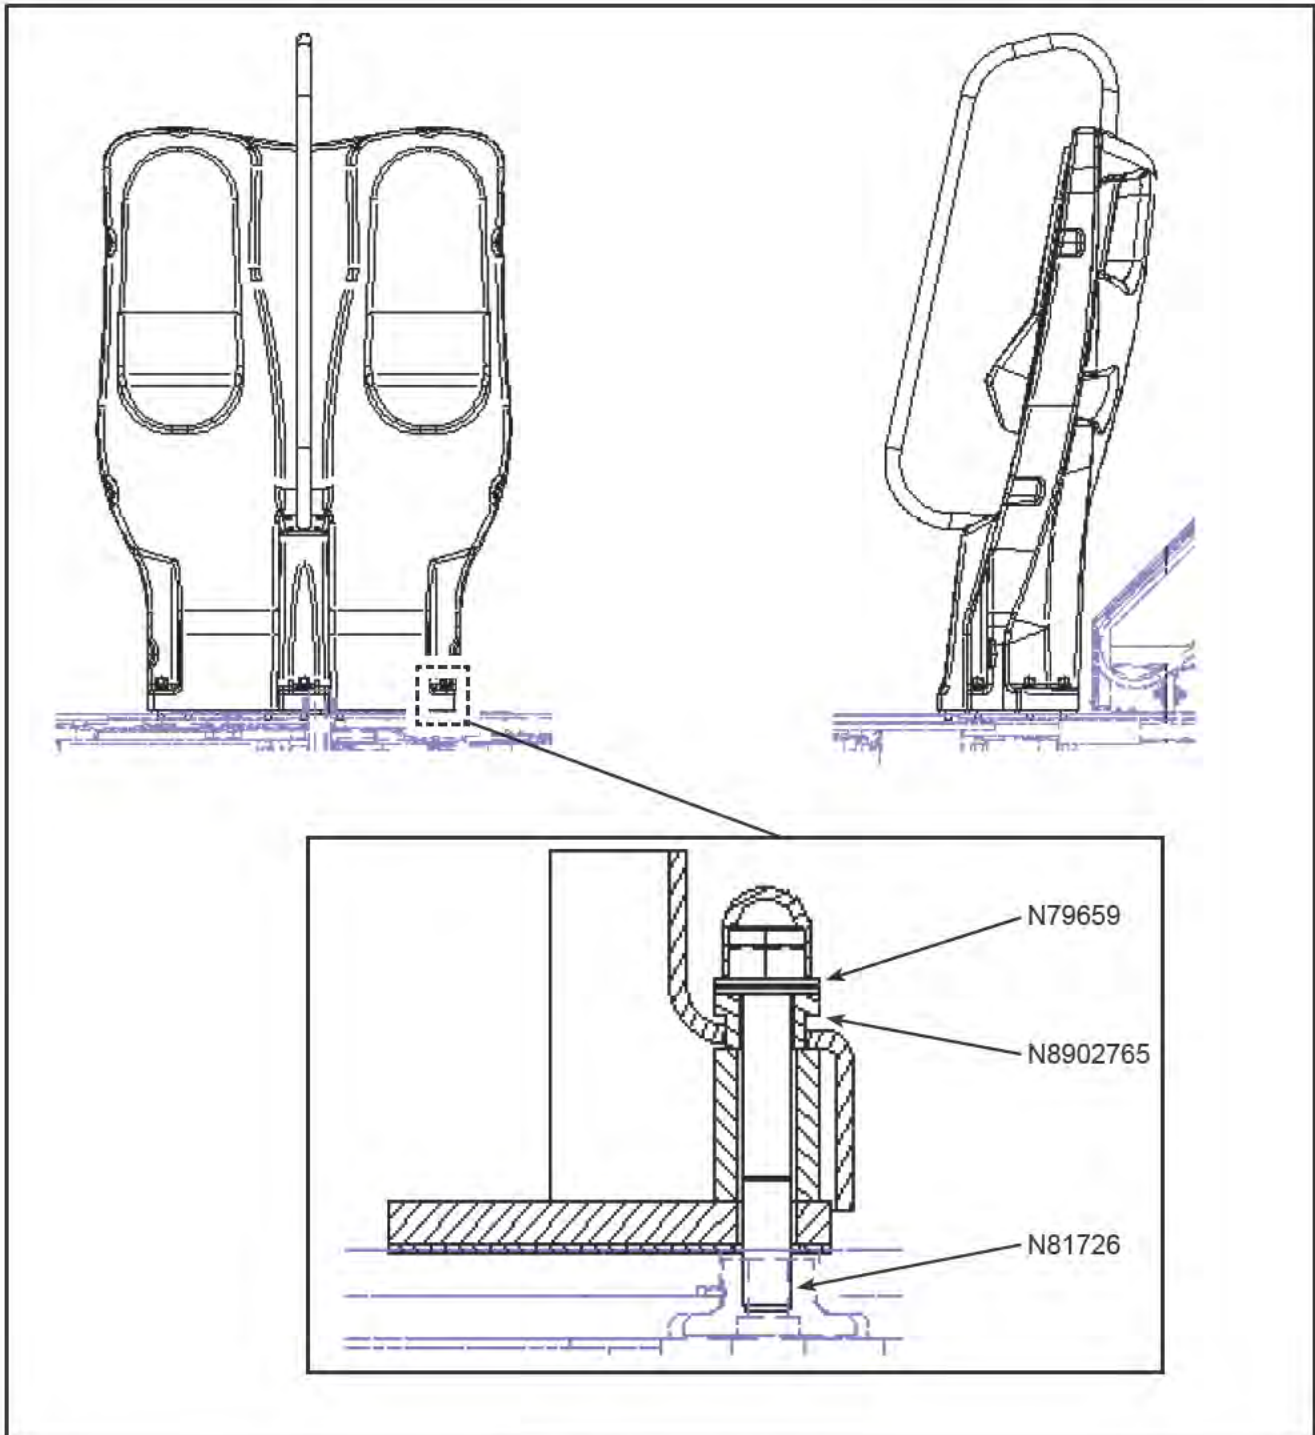
Figure 2 - Hardware Location

LEVEL	DESCRIPTION	DIRECT CHARGES		TIME
		LABOUR	MATERIAL	
1	Bushing added to prevent torquing of bolt directly on the shell.	Nova Bus	Nova Bus	1 h
2	–	–	–	–

- 1.2. Install the new bum rest shells using the new bushing N8902765, self-locking washer N79659 and screw N81726. Torque to 30.2 lb-ft (41 N•m). See Figure 2. Typical for 7 locations.
