GROUP BOD	MODEL 2015~2016MY Sedona (YP)
	NUMBER 119	DATE November 2015
TECHNICAL SERVICE BULLETIN		
SUBJECT: COMBINED TSB/SERVICE ACTION: FUEL FILLER DOOR ADJUSTMENT (SA 202)

SUBJECT: COMBINED TSB / SERVICE ACTION: FUEL FILLER DOOR ADJUSTMENT (SA 202)

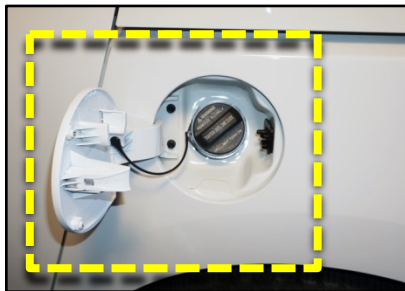
This bulletin provides the procedure to adjust the fuel filler door spring of some 2015~2016MY Sedona (YP) vehicles, produced from July 29, 2014 through June 15, 2015, which may exhibit a fuel filler door that may not pop open or does not open far enough. To correct and/or prevent this condition, Kia is requesting the completion of this Service Action on all affected vehicles, including those in dealer stock, prior to delivery. Before conducting the procedure, verify the vehicle is included in the list of affected VINs.

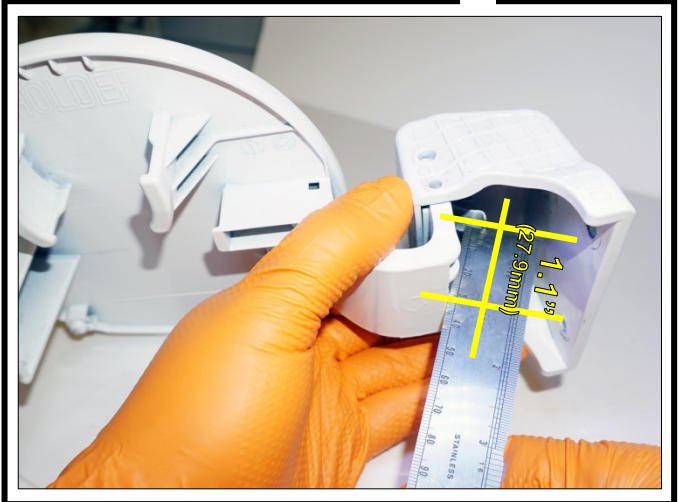
3. Use a ruler to measure the distance from the spring to the edge of the door hinge, as shown. If the distance measured is less than 1.1" (27.9 mm), proceed to the next step. If the distance is greater than 1.1" (27.9mm), no further action is required.
