GROUP BOD	MODEL 2016MY Sorento (UMa)
	NUMBER 114 (REV 1, 09/30/2015)	DATE September 2015
TECHNICAL SERVICE BULLETIN		
SUBJECT: SERVICE ACTION: SUNVISOR INSPECTION/REPLACEMENT (SA197)

SUBJECT: SERVICE ACTION: SUNVISOR INSPECTION/REPLACEMENT (SA197)

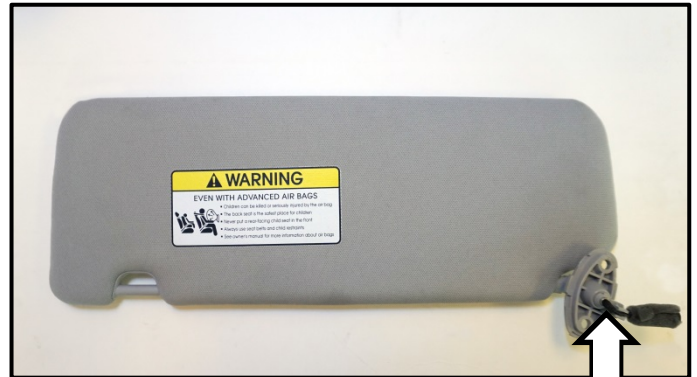
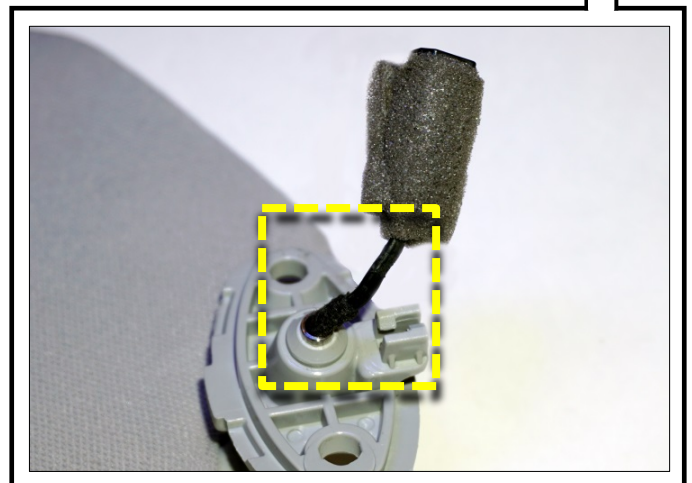
5. Place the sunvisor on a clean work surface, remove the harness from the holder and inspect it for exposed wiring. If the harness shows no visible signs of damage, proceed to step 6. If the harness shows visible signs of damage, proceed to step 7.
