GROUP CHA	MODEL 2011~13MY Sorento (XMa)
	NUMBER 059	DATE August 2015
TECHNICAL SERVICE BULLETIN		
SUBJECT: 2WD HUB/REAR WHEEL SPEED SENSOR REPLACEMENT

This bulletin provides the procedure to replace the rear wheel hubs of some of Sorento (XMa) vehicles, produced from Job #1 through April 4th, 2012, which may experience a Diagnostic Trouble Code (DTC) (C1206 ~ C1211) due to possible water intrusion into the rear wheel speed sensor. To enhance customer satisfaction, this bulletin outlines the replacement of BOTH rear wheel hub assemblies to resolve the concern.

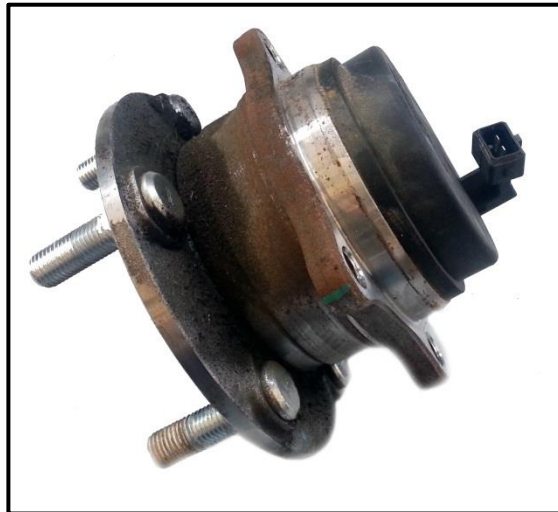
- C1206 Wheel Speed Sensor Rear-LH Open/Short
- C1207 Wheel Speed Sensor Rear-LH Range/Performance/Intermittent
- C1208 Wheel Speed Sensor Rear-LH Invalid/No Signal
- C1209 Wheel Speed Sensor Rear-RH Open/Short
- C1210 Wheel Speed Sensor Rear-RH Range/Performance/Intermittent
- C1211 Wheel Speed Sensor Rear-RH Rear-LH Invalid/No Signal
