GROUP <b>Electrical</b>	MODEL <b>2015MY Sorento (XMa)</b>
	NUMBER <b>087</b>	DATE <b>August 2015</b>
<b>TECHNICAL SERVICE BULLETIN</b>		
<b>SUBJECT: eServices DATA CANNOT BE TRANSMITTED</b>

This bulletin provides the procedure for upgrading the navigation system of some 2015MY Sorento (XMa) vehicles, produced from April 2, 2014 to July 31, 2014, which may experience the following concerns :

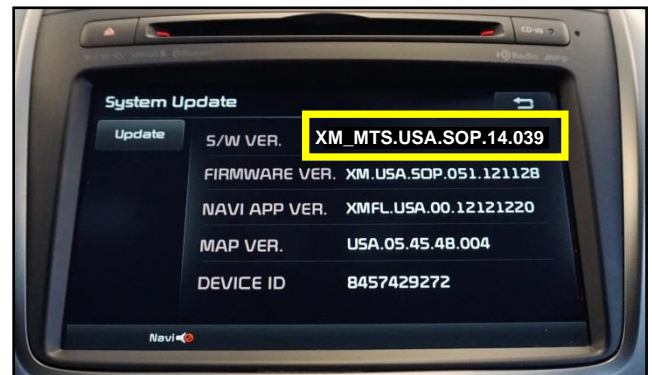
5. Compare the original Software Version (S/W) to the versions shown in the table shown below.

ORIGINAL S/W VERSION
XM_MTS.USA.SOP.14.039

Do **NOT** update navigation head units with the following S/W versions (or higher):

- XM\_MTS.USA.SOP.14.039T
- XM\_MTS.USA.SOP.14.046
- XM\_MTS.USA.SOP.14.048

Updating any S/W versions other than XM MTS.USA.SOP.14.039 may result in a software mismatch between the head unit and the map SD Card or a “bricked” head unit.

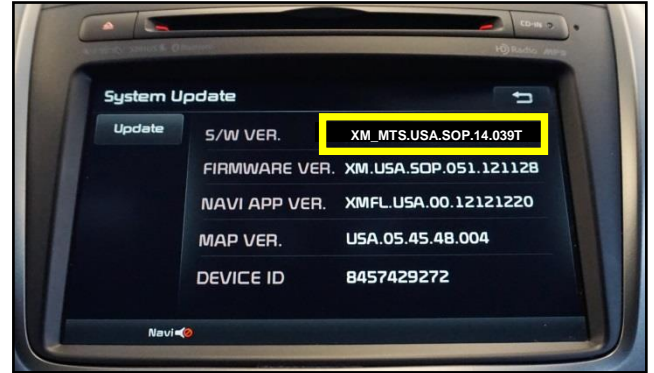
13. Confirm the upgrade software version matches the information shown in the table below:

<b>Upgrade Software Version</b>
<b>XM_MTS.USA.SOP.14.039T</b>
