Bulletin No.: 15642  
Date: December 2015

# Service Bulletin

**SUBJECT:** Special Coverage Adjustment - Side Impact Airbag Connectors

**MODELS:** 2011 Chevrolet Volt

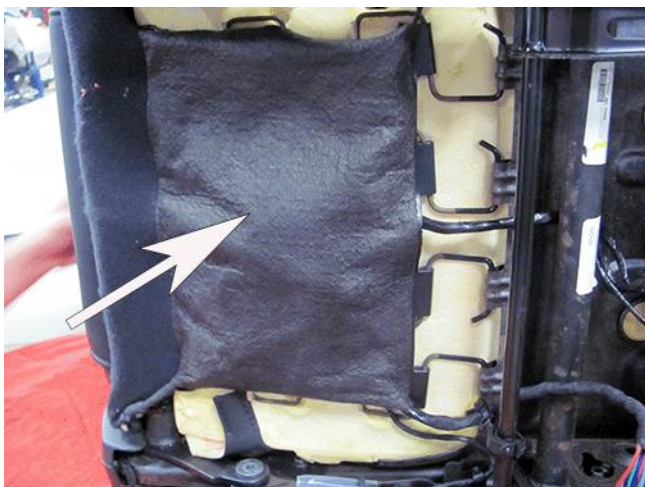
4325289

1. Disable the Supplemental Inflatable Restraints (SIR) system. Refer to *SIR Disabling and Enabling* in SI.
2. Remove the affected seat. Refer to *Driver or Passenger Seat Removal and Installation* in SI.
3. Place the seat on a clean, covered work surface. Position the seat so you can access the yellow Side Impact Airbag (SIAB) harness connectors on the underside of the seat cushion.

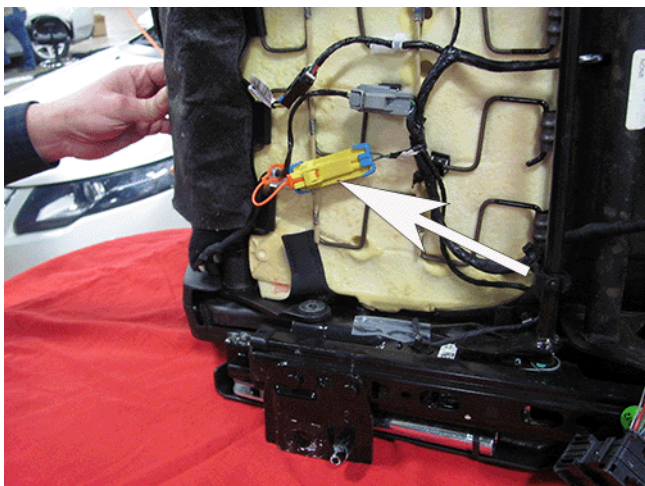
4325291

4. Remove the protective fabric as necessary.

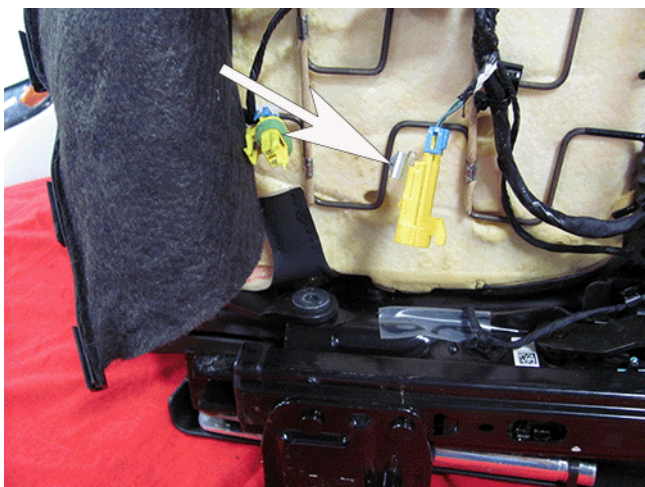
4325293

5. Locate the yellow Side Impact Airbag (SIAB) harness connector.

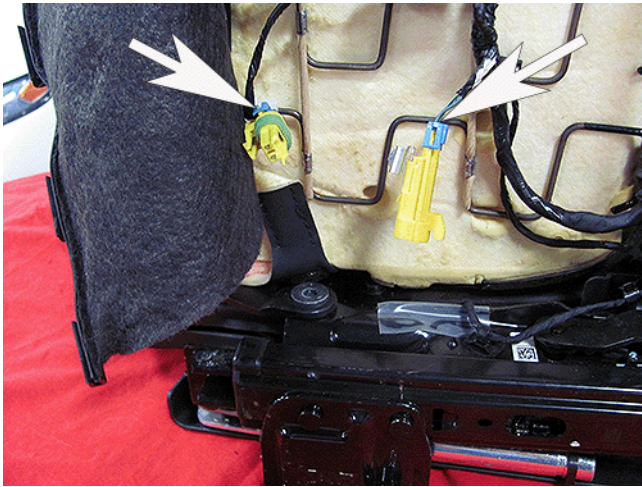
4325294

6. Remove the connector from the seat spring by releasing the metal clip.

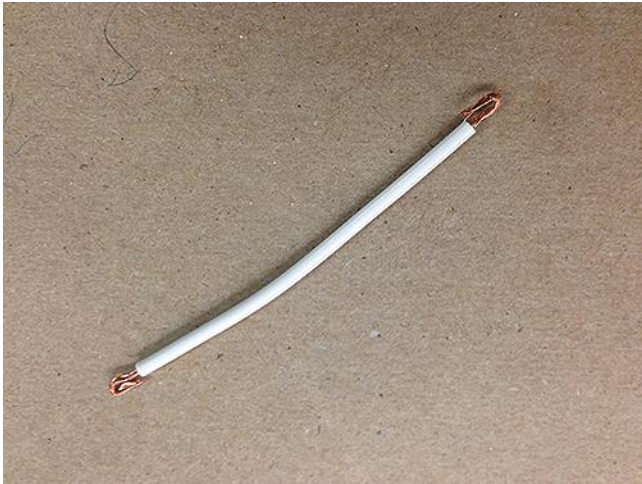
4325295

7. Using side cutters, cut the connectors from both sides of the seat harness as close to the connector as possible.
8. Strip off approximately 13 mm (1/2 in) of insulation from the wiring ends. Fold the wires.
9. Add one approximate 38 mm (1.5 in) section of heat shrink tube to each of the four wires.

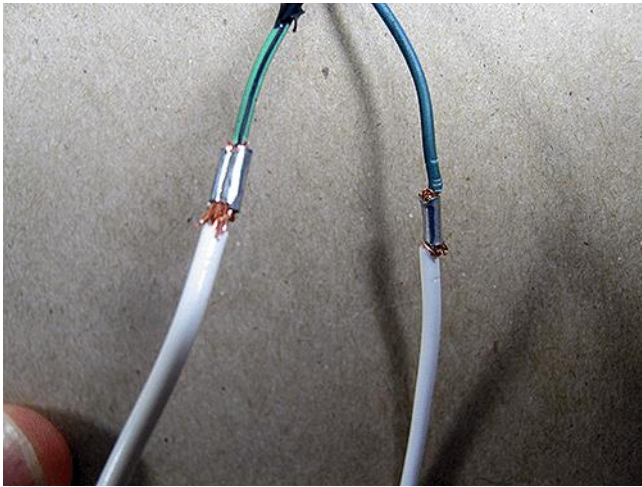
4325296

10. Prepare two approximate 75 mm (3.0 in) length jumper wires. Use locally sourced 0.8 sq mm (18 gauge) wire for the jumper wires. Strip off approximately 13 mm (1/2 in) of insulation from the wiring ends. Fold the wires as shown.
11. Insert the two jumper wires between the four harness wires. Ensure the correct wire colors are aligned.

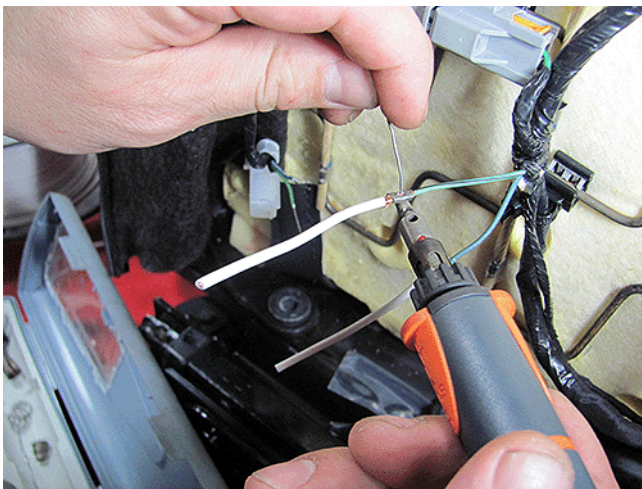
4325297

12. Crimp a splice clip over the joined wires using Special Tool J-38125-8, nest F. Verify the crimp quality. Repeat this crimp process on all four wire connections.

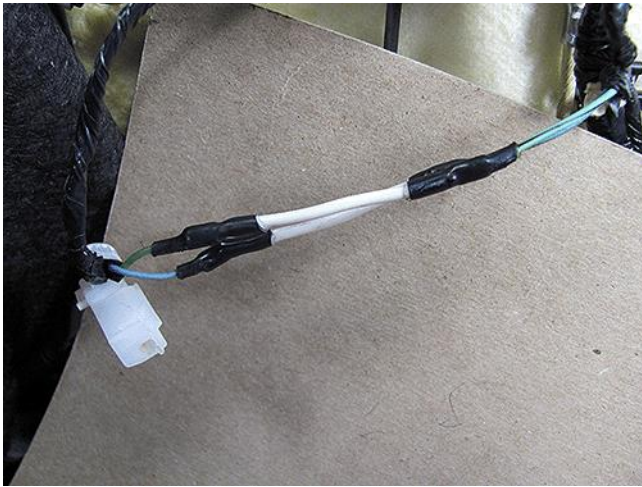
4325298

13. Solder all four crimp and splice clips using the Ultratorch, part number J-38125-5, or another butane fueled soldering iron.
