Service Bulletin

SUBJECT: Service Update for Inventory and Customer Vehicles
Harness Trapped Under MBEC
Expires with Base Warranty

MODELS: 2016 Chevrolet Silverado HD
2016 Chevrolet Silverado LD
2016 GMC Sierra HD
2016 GMC Sierra LD

Subject: 22860 – Service Update Bulletin
Harness Trapped Under MBEC

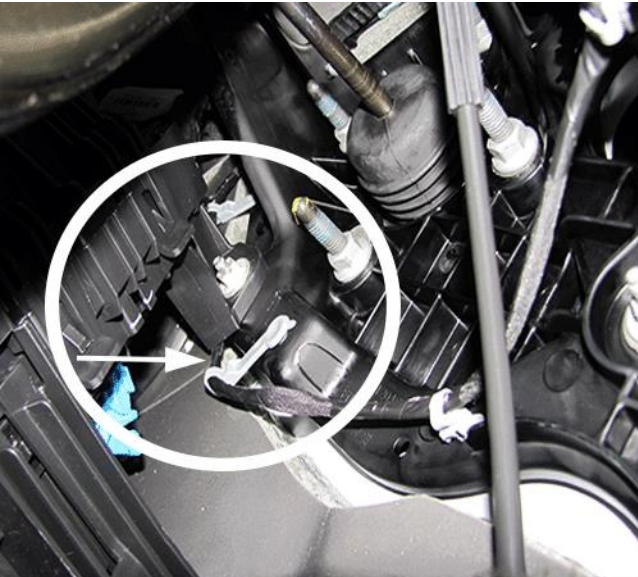
- If the brake clutch harness is routed as shown above (behind the body wiring harness junction block stand off), no further action required.
