# Program Bulletin

## CUSTOMER SATISFACTION PROGRAM

**SUBJECT:** SiriusXM Travel Link Feature Availability

Subject: 15747 - Customer Satisfaction Program  
SiriusXM Travel Link Feature Availability

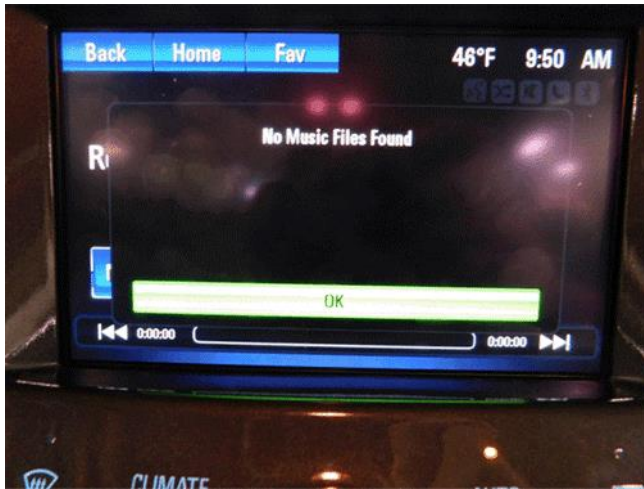
4341290

10. A No Music Files Found message will appear on the screen. Press OK to dismiss the message.

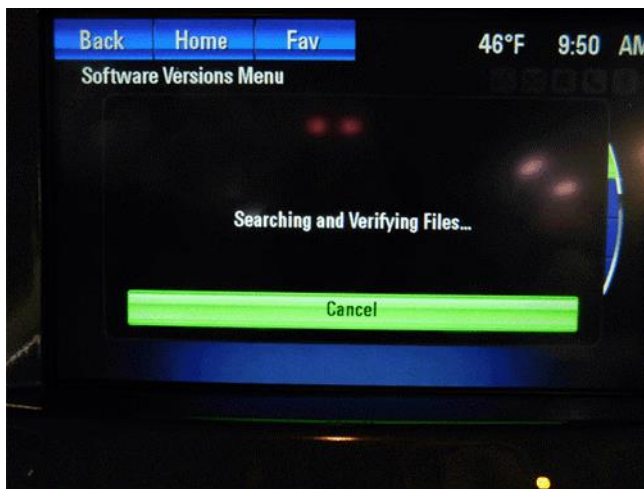
4341292

11. Using the radio controls, select the following: Config>Radio Settings>Software Versions Menu>Update Radio Software.

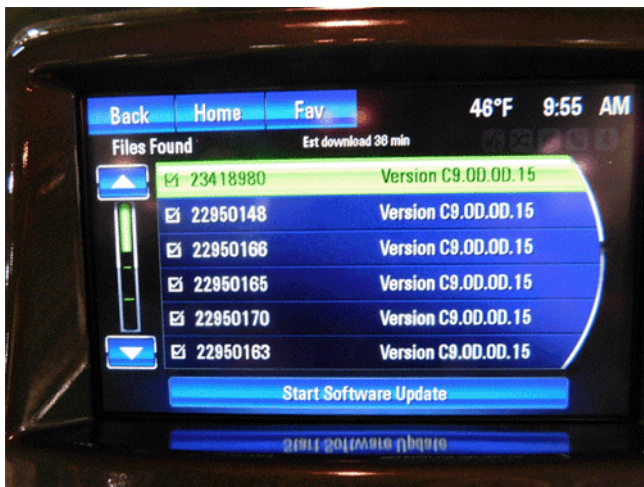
4341295

12. Select Start Software Update when prompted.
