# Service Bulletin

**SUBJECT:** Service Update for Inventory and Customer Vehicles  
Harness Trapped Under MBEC  
Expires with Base Warranty

**MODELS:** 2016 Chevrolet Silverado HD  
2016 Chevrolet Silverado LD  
2016 GMC Sierra HD  
2016 GMC Sierra LD

Subject: 22860 – Service Update Bulletin  
Harness Trapped Under MBEC

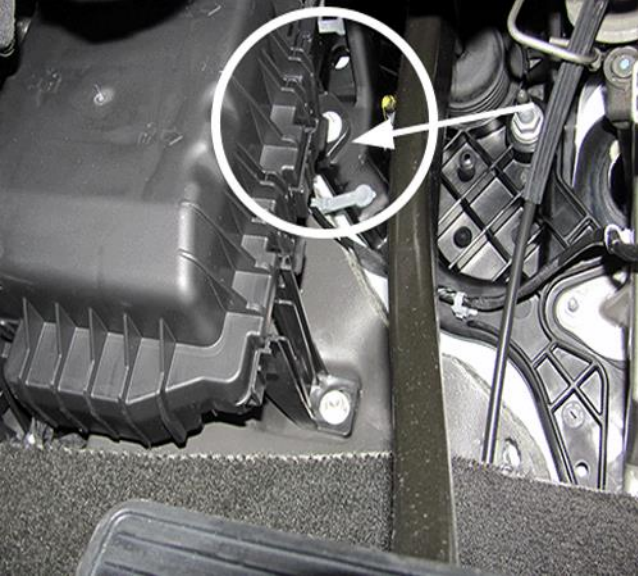
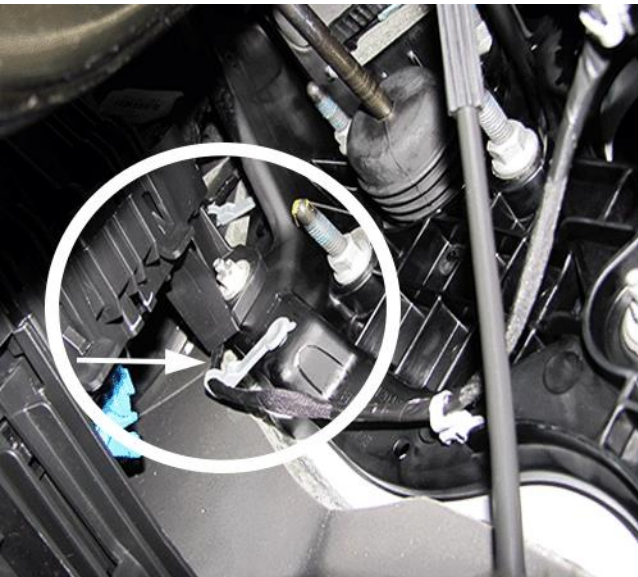
- If the brake clutch harness is routed as shown above (behind the body wiring harness junction block stand off), no further action required.

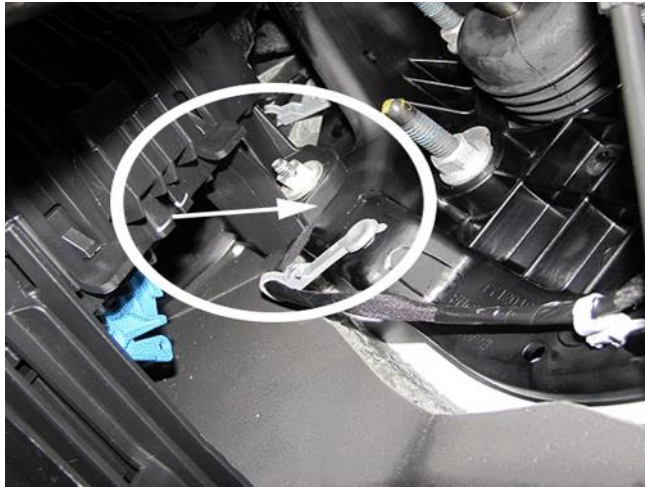
- If the brake clutch harness is trapped or pinched under the body wiring harness junction block stand off as shown, continue to step 3.
3. Remove the 3 body wiring harness junction block nuts.
  4. Inspect the brake clutch harness for any damage and repair as necessary. Refer to *Wiring Repairs* in SI.
  5. Gently lift the body wiring harness junction block and reroute the brake clutch harness away from the mounting stud of the body wiring harness junction block.
  6. Install the body wiring harness junction block back in place and install the mounting nuts.
