Bulletin No.: 15116  
Date: November 2015

## CUSTOMER SATISFACTION PROGRAM

**SUBJECT:** Hood Striker Corrosion / Fracture

**MODELS:** 2015-2016 Chevrolet Colorado  
2015-2016 GMC Canyon

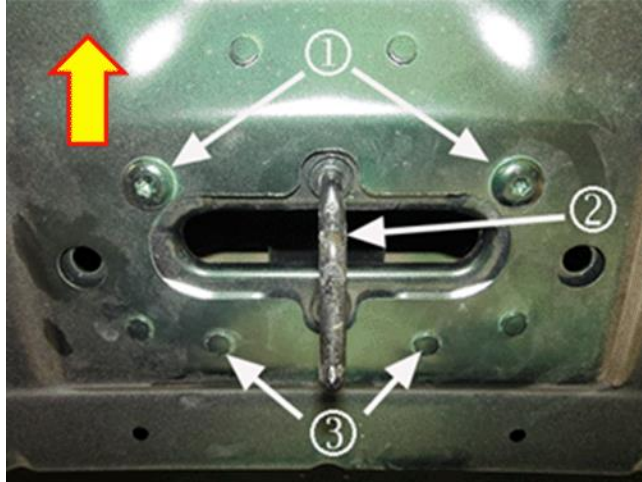
4170778

- (1) Forward screws
- (2) Stationary hood striker
- (3) Rear, inboard hood clinches

1. Open the hood and verify components noted above.
