GM Bulletin No.: 15796 Date: November 2015

SUBJECT: Service Update for Inventory Vehicles Only SDM Stud Misalignment Expires with Base Warranty

MODELS: 2016 Chevrolet Silverado 2016 GMC Sierra

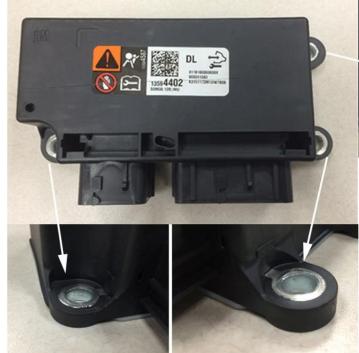
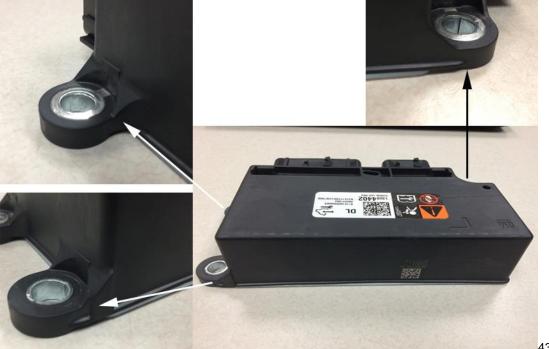
4323720

This bulletin provides a service procedure to replace the SDM on **certain** 2016 model year Chevrolet Silverado and GMC Sierra vehicles. These vehicles may have a small hairline crack in one of the mounting feet securing the Sensing and Diagnostic Module to the floor pan of the vehicle. Under certain conditions, the issue could potentially cause the SDM to not perform as intended. If the SDM does not perform as intended, there may be a risk of occupant injury.

4. Take pictures of the front and back of the SDM mounting feet as shown in the pictures above.
